EFFECT OF SLOW-MOVING LANDSLIDES ON CHURCHES IN THE LIGURIA REGION: A GEOTECHNICAL APPROACH

Keywords: Slow-moving landslide, Historic masonry churches, Damage assessment.

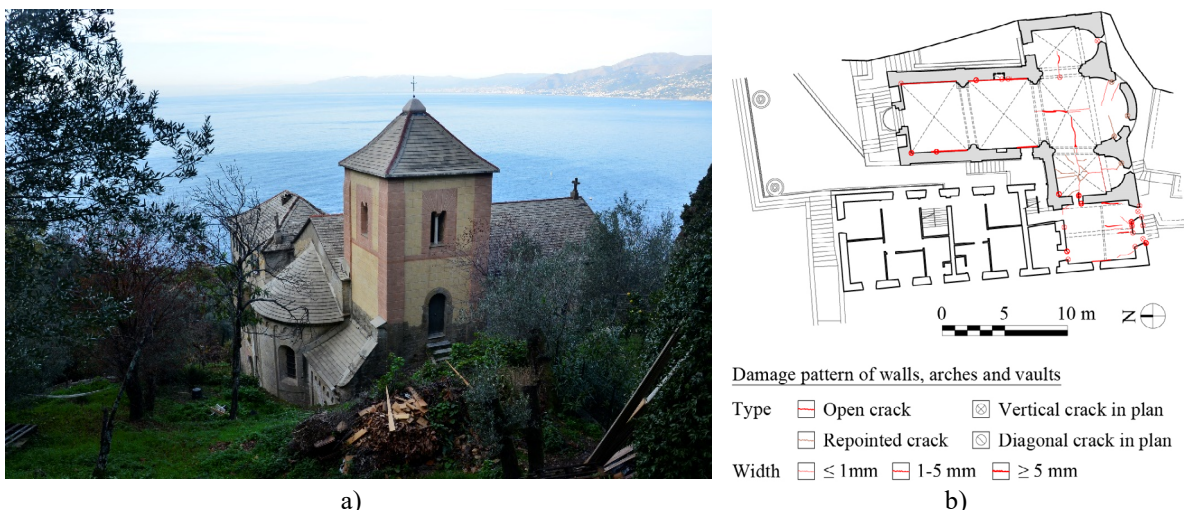
Figure 1: San Nicolò di Capodimonte church: a) exterior view, b) damage pattern.

The church presents slight to moderate damage. Few thin (width up to 1 mm) and medium (width between 1 mm and 5 mm) vertical cracks can be observed in the longitudinal walls as well as in apse wall above the windows. The vaults of the transept present cracks oriented parallel and perpendicular to the longitudinal axis of the church. Regarding the Fishermen's house, the authors were given access only to the building portion adjacent to the church. Extensive and severe damage was found in this area. In particular, large (width equal or larger than 5 mm) vertical cracks developing from the level of the ground were observed in the external wall continuous with the wall of the church apse.

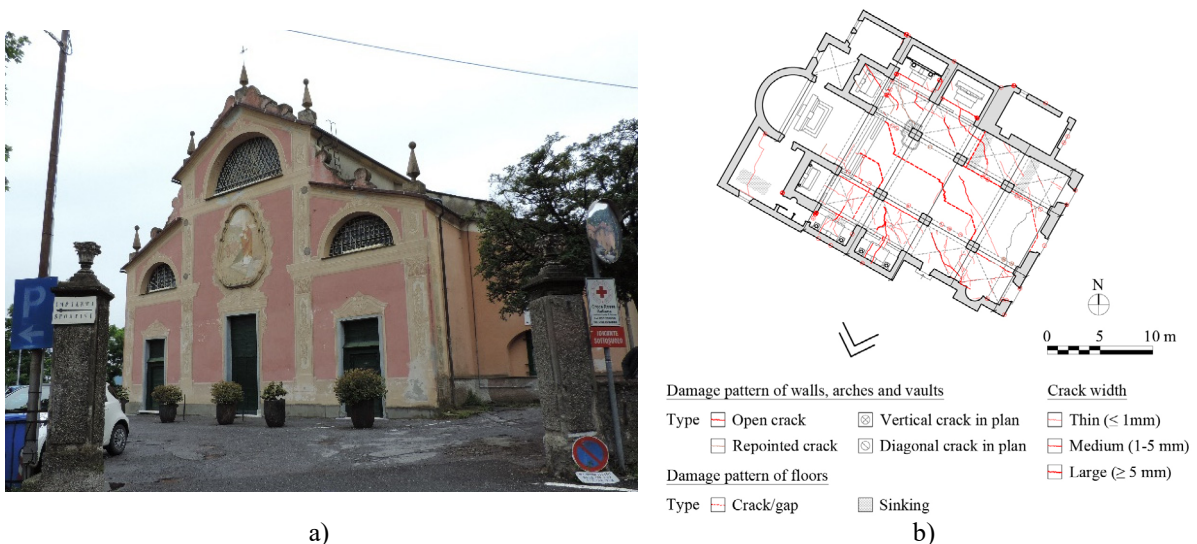
Figure 5 – Sant’Olcese church: a) exterior view, b) damage pattern (the direction of the landslide acting in the area is indicated with an arrow).

The church presents extensive and heavy damage, in particular in floors and vaults. Damage in the floor appears in the form of parallel gaps among tiles (ranging from 2 to 5 mm in width) and localized sinking. Extensive damage can be observed in the vaults with diagonal shear cracks widespread throughout the building. It can be observed that these cracks, which exhibit the same orientation in all the vaults, reflect the gaps observed in the floor, both being oriented almost perpendicular to the landslide direction (indicated with an arrow in Figure 5b). Finally, walls are affected by few minor vertical cracks.

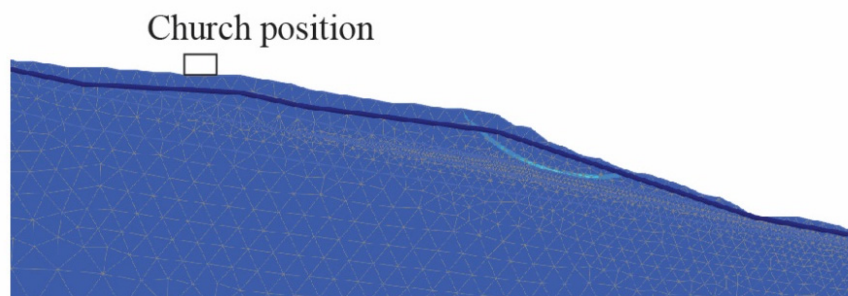
Both horizontal and vertical patterns of displacement were evaluated. The results show only very small displacements (less than 1mm) in the section under the church while an area of instability downhill of the church was identified (Figure 7). However, the latter is too far away from the building to influence its behavior.

The results of numerical analyses do not appear to be in good agreement with the crack pattern observed in the church. In fact, the heavy damage exhibited by the building as well as the occurrence of parallel cracks in vaults and floors oriented perpendicular to the landslide direction clearly indicates that the church has been subjected to slope movements. The absence of significant soil displacements obtained from numerical analyses can be attributed to the fact that the lack of detailed geotechnical data did not allow for an accurate modeling of the soil. The latter could be achieved by performing new in-situ tests and boreholes, especially in the area downhill of the church, in order to obtain a detailed stratigraphy and fully characterize soil parameters.

Figure 7: Shear strain concentration in area downhill of the church.

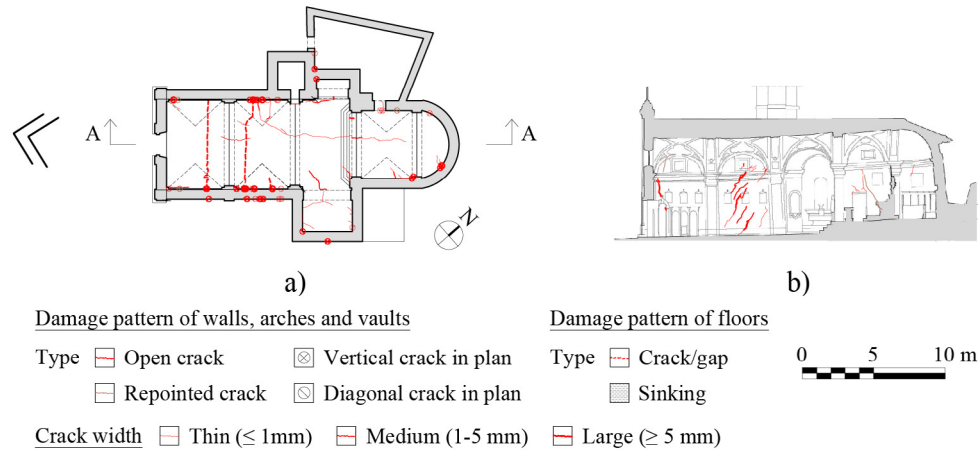
Figure 8a-b presents the crack pattern of San Carlo church in plan and elevation. The building exhibits extensive and severe cracking as well as large deformations. The floor presents two large parallel gaps (the largest one with a width of 18 mm) crossing the entire floor and propagating between longitudinal walls (Figure 8a). These gaps continue up into the walls with a diagonal orientation. Regarding cracking of walls, the most important damage is observed in the second bay behind the façade where series of severe diagonal cracks propagating from the level of the ground and developing upwards towards the apse are observed in both the longitudinal walls (Figure 8b). As for arches and vaults, they exhibit only few and

slight damage. In particular, a thin longitudinal crack is present in the barrel vault at mid-span. Thanks to the deformation survey performed in [15], the presence of large deformations can be observed (Figure 8b). In particular, a significant rotation of the apse towards the interior of the church can be detected. Furthermore, it can be observed that the left part of the church, where the bell-tower is located, experienced a larger settlement with respect to the right one [15].

Figure 8: Damage survey of San Carlo church in Cassingheno: a) plan, b) section AA. (The direction of the landslide acting in the area is indicated with an arrow).

The presence of severe cracks localized in the second bay of the church as well the settlement experienced by the left part of the church with respect to the right one can be attributed to the occurrence of differential settlement in this area. These displacements could have been responsible for the structural instability of the bell tower, which was strengthened in 1988. It is evident that such local phenomena cannot be captured when modeling the behavior of the entire slope.

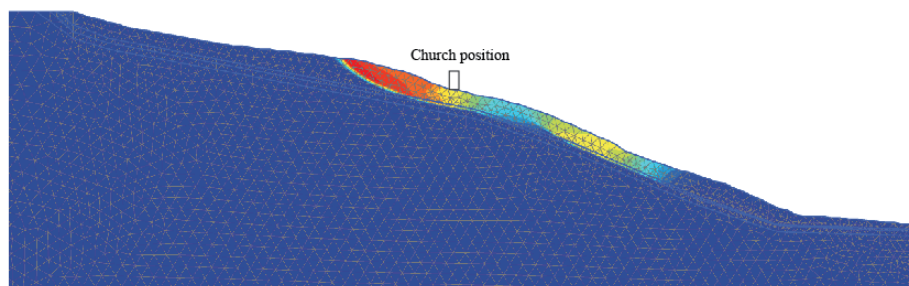
The results show that the church is located in an area of potential instability (Figure 10) and is subjected to horizontal and vertical displacements of the same order of magnitude.

Regarding horizontal displacement, a maximum value of about 20 mm is obtained under the church when analyzing the slope section along landslide direction. This displacement value is in good agreement with the horizontal displacement recorded by the inclinometers and reflects the width of the gaps of the floors. These latter can be, indeed, attributed to the significant horizontal movement experienced by the church in the direction of the landslide. As for vertical displacements, they may explain the rotation of the apse towards the interior of the church.

Figure 10: Total displacements $|u|$.
