## Effect of slow-moving landslides on a vaulted masonry building: The case of San Carlo Borromeo church in Cassingheno (Genova)

**ABSTRACT:** This paper presents the structural analysis of San Carlo Borromeo church, a masonry building located in Cassingheno (Genoa, Italy) in an area affected by a slow-moving landslide. A deep knowledge of the building in terms of geometry, structural configuration, history and construction phases was acquired by means of on-site surveys and archival research. The crack patterns were surveyed in detail and the deformations were studied through a point cloud obtained from a LIDAR survey. The comparison between the landslide direction and the damage observed showed discrepancies and suggested the presence of foundation settlements due to other phenomena. To identify the actual causes of damage, a finite element model (FEM) of the building in its hypothetical undeformed configuration was created. The geometry of such configuration was reconstructed starting from the point cloud obtained from the LIDAR survey and removing geometrical defects such as leaning of walls, deformation of vaults and inclination of tie-rods. To simulate the effects produced b

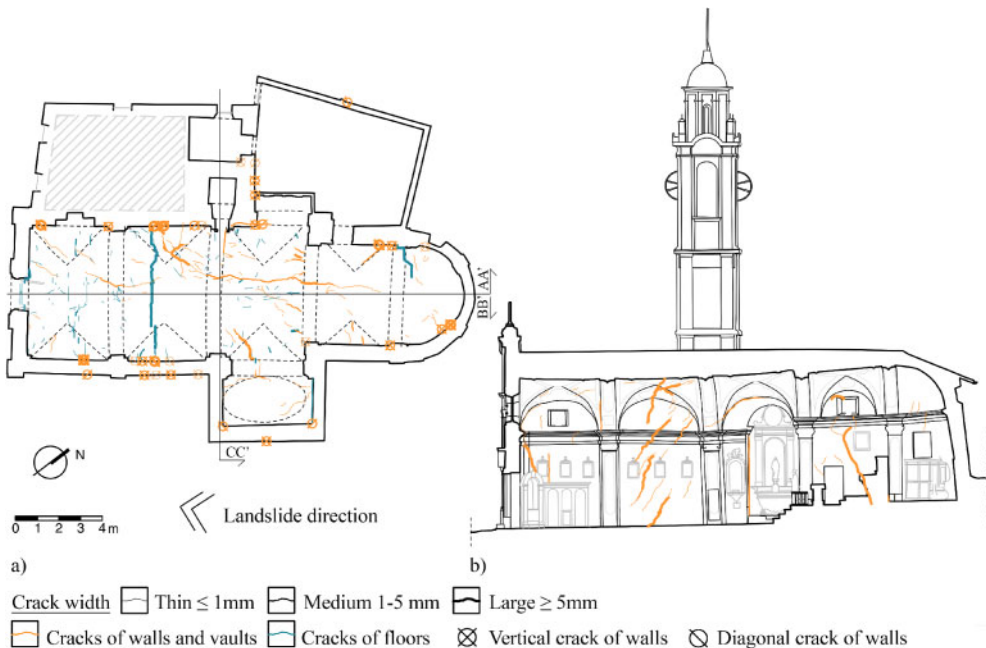
Figure 4 shows the crack pattern of San Carlo Borromeo church. Since in 2019 the church underwent a restoration that partially hid the damage on the exteriors, the crack pattern surveyed by the authors in 2020 was integrated with the one reported in Memme (2019) and Ferrero et al. (2021a).

Extensive and severe damage is observed in the walls, in particular in the second bay behind the façade. In this bay, both the longitudinal walls are affected by a series of large diagonal cracks that originate from the level of the floor and propagate upwards towards the apse. In addition to these cracks, large diagonal cracks are observed in the longitudinal walls of the first bay of the nave and the presbytery. Both cracks progress upwards towards the façade of the church (Figure 4(b)).

Unlike walls, arches and vaults do not show severe cracking. A thin to medium longitudinal crack, oriented in same direction as the landslide, cuts the barrel vaults of nave and presbytery approximately at mid-span. Thin cracks with a slight concentric pattern around the belltower can also be observed.

Figure 4. Crack pattern of San Carlo Borromeo church: a) plan, b) section AA'.

As can be seen from Figure 4(a), in the second bay behind the façade, the floor presents a large crack (12 mm wide), which crosses the entire nave and propagates transversally between the longitudinal walls. Thin to medium cracks with the same orientation were also observed in the first bay and the northernmost part of the right chapel. These cracks are oriented perpendicular to the direction of the landslide acting in the area.

As regards the crack pattern, the cracks of the floor oriented perpendicular to the landslide direction can be attributed to the horizontal component of the landslide movement and clearly indicate that the church suffered an extension in the direction of the acting landslide. However, the cracks in the barrel vault of the nave as well as the diagonal cracks in the walls on the left and right sides of the belltower, which progress upwards toward this latter, suggest a local settlement of the belltower. Such a settlement could also be responsible for the deformation of the second arch from the façade.

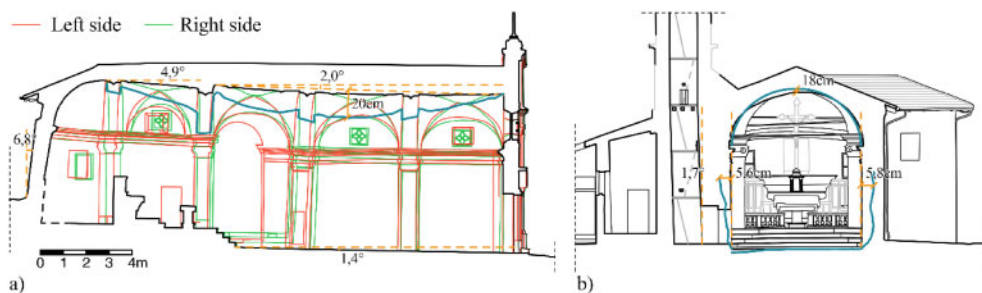
From the analysis of the longitudinal section (Figure 5(a)), it can be seen that the whole building exhibits a significant rotation toward the valley, in the direction of the landslide. The more significant rotations were measured in the apse and presbytery. The presbytery vault was rotated by about  $4.9^\circ$ , the apse wall by  $6.8^\circ$ , and the moldings by  $3^\circ$ . In the nave, the floor, moldings, and pilasters show a rotation of only about  $1.4^\circ$ , while the barrel vault exhibits a deflection of about 20 cm in the center of the second bay. No significant rotations were measured in the façade.

Figure 5. Deformation surveyed. a) Longitudinal section BB', b) transversal section CC' (the sections are indicated in the plan of the church in Figure 4).

From the analysis of the transversal section (Figure 5(b)), the walls of the nave were found to lean outwards. The right wall has the maximum rotation of  $1.6^\circ$  near the first pilaster from the façade, probably due to the thrust of the vault. The left wall, which experienced larger rotations, exhibits the maximum one in correspondence of the belltower, which presented the same rotation of  $2.14^\circ$ .

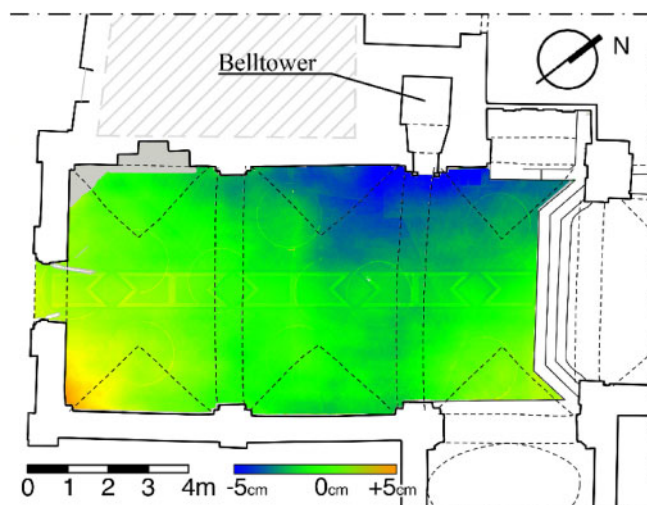
The belltower underwent a localized settlement of about 11 cm, measured by comparing the height of the capitals of the pilasters on the left and right parts of the church. The localized settlement of the belltower can be easily identified in Figure 6, which shows the vertical distance between the points of the floor taken from the point cloud and their best fit plane passing through the floor (Pesci et al. 2011).

Figure 6. Local settlement of the belltower identified by analyzing the vertical distance between the points of the floor taken from the point cloud and the best fit plane passing through the floor.

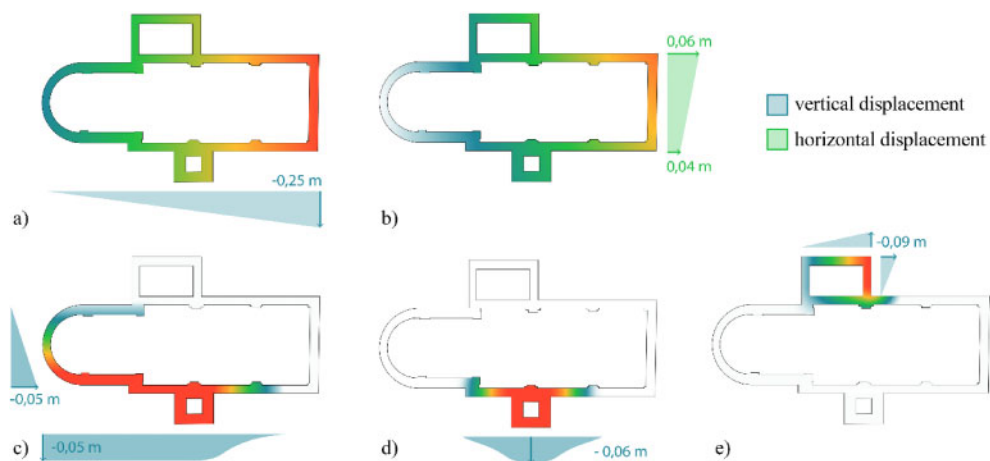
The analysis of the deformation and foundation settlements indicates that not all the damage suffered by the church was produced by the landslide. Indeed, while the vertical component of the landslide has reasonably caused of the global rotation of building (Ferrero et al. 2021a), it has hardly produced the differential settlement between the left and the right part of the building and the localized settlement of the belltower.

On the basis of the deformation and foundation settlements identified in San Carlo Borromeo church, four displacement fields, representing the displacements experienced by the building over time, were identified: a global displacement, affecting the entire church, and three local displacements. The global displacement is due to the landslide and has both vertical and horizontal components (Figure 7(a–b)), while the local displacements represent the vertical settlements of the left part of the church (Figure 7(c)), the belltower (Figure 7(d)), and the right chapel (Figure 7(e)).

Figure 7. Displacement fields: a) vertical component of global displacement, b) horizontal component of the global displacement, c) left portion of the church, d) belltower, e) right chapel.

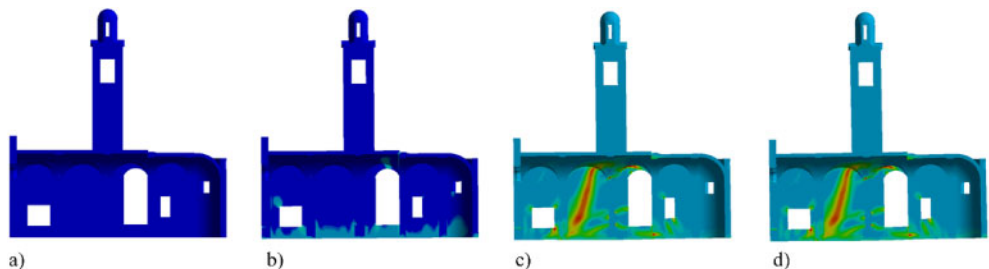
Figure 9 shows the results obtained in correspondence of each step of the displacement scenario. As shown in Figure 9(a), the application of the dead loads did not cause any plastic deformation, which, in contrast, appeared as soon as foundation displacements were imposed (Figure 9(b)). The application of the global landslide displacement caused a concentration of plastic deformation at mid-span of the arches that separate the nave from the lateral chapels, probably due to the smaller stiffness of this portion of the church (Figure 9(b)). During the survey, cracks were observed at the same locations, and the phenomenon presented a moderate intensity both in the numerical model and in the building.

As shown in Figures 9(c) and 10, the application of the foundation displacements of the belltower and the left part of the building produced the most significant damage and was responsible for most

Figure 9. Maximum principal plastic strain produced by: a) dead loads, b) 1/3 global displacements, c) 1/3 global displacement plus displacements of the left portion of the church and belltower d) 1/3 global displacement plus displacement of the right chapel.

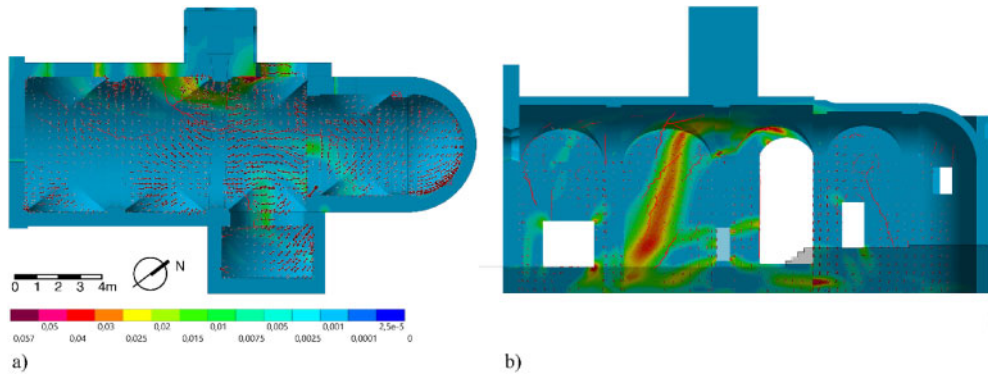
of the cracks observed in the vaults and in the walls of the left side of the church. In particular, the occurrence of the large crack detected in the wall of the second bay during on-site inspections was accurately simulated. This can be seen from Figure 10(b), in which the crack pattern surveyed in-situ is overlapped to the results of the numerical simulations. As regards the vaults of the nave (Figure 10(a)), the formation of the cracks due to the application of the foundation displacements of the belltower and the left part of the building proves that these cracks are not produced by the landslide and thus explain why they are oriented parallel to the landslide direction.

Figure 10. Comparison between FE results (in terms of maximum principal stress  $\sigma_1$  vectors and maximum principal strain  $\varepsilon_{1,pl}$  contours) and crack pattern surveyed on site: a) vaults, b) north-western wall (section AA').

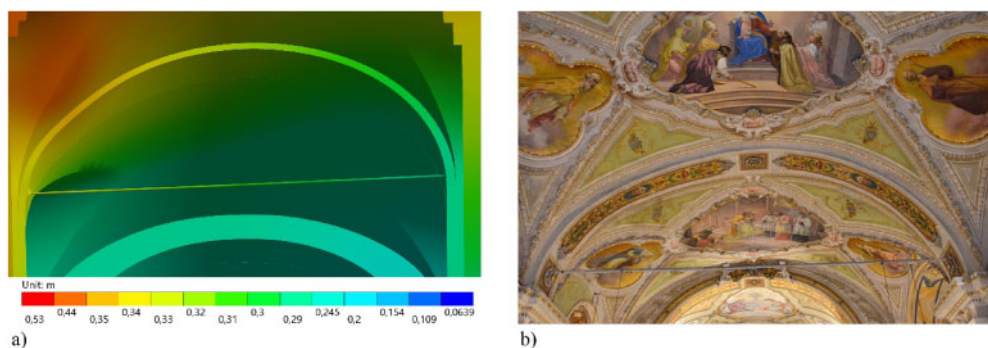
In conclusion, a good agreement was obtained between the damage and deformations predicted by the numerical simulations and those observed on-site, even though the actual deformation of the church was underestimated. The complex rotation of the belltower, which leans both downstream and towards the left side of the church, and the deformation of the arch nearby were also accurately simulated (see Figure 11), proving the reliability of the numerical model.

Figure 11. Deformation of the second arch from the façade. a) FE results (total displacement), b) real damage.
