Model Scale Investigation of Blade Root Cavitation Erosion on a Set of Marine Propellers

Afaq Ahmed Abbasi ¹, Giovanni Franzosi ¹, Daniele Bartetta ², Marina Delucchi ³,
Michele Viviani ¹ and Giorgio Tani ¹

ABSTRACT

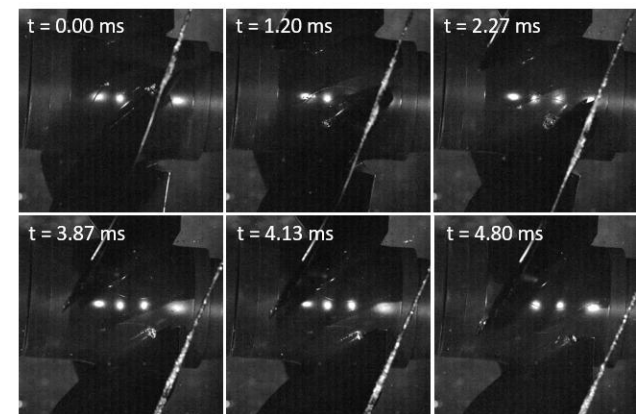
Figure 3. Cavities dynamics (structure, evolution and collapse) for P1 Propeller

The dynamics of cavities for P1 propeller is reported in sequence of frames showing evolution and collapse of a bubble. In most cases bubbles behave as single bubble, generated between the leading edge and mid-chord and

the volume of bubble grows while they are convected downstream. The maximum of the volume is reached around the 75% of the chord, that is at time 2.27 ms in the sequence. Then the volume of the bubble contracts, gradually at first, then suddenly while the bubble reached the trailing edge where collapse occurs.

The collapse occurs in slightly different forms depending on the size and location of the bubble. Larger cavities destabilize from the centre, creating a number of minor cavities, some of them usually collapse with a rapid volume contraction towards the point where paint removal is observed, i.e., a small area at the trailing edge of the blade fillet, including also part of the hub surface.

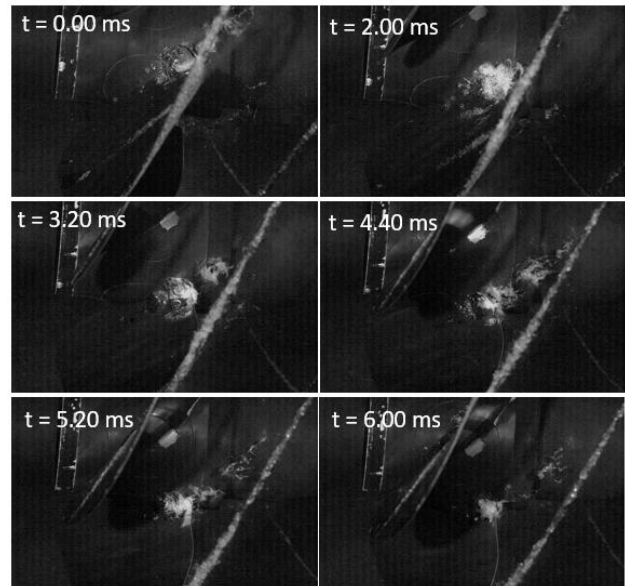
Figure 5. Cavities dynamics (structure, evolution and collapse) for P2 Propeller

Figure 5 reports a sequence of frames describing the evolution of this global cavitation structure for P2 propeller.

In this short sequence, the structure size increases and reaches its maximum at 2 ms, then it starts contracting again towards the blade root (3.2 ms and 4.4 ms). During this contraction of the main cavity, the collapse of minor cavities is observed out of the outer edge of the main cavity, often generating cloudy structure and rebound events (5.2 ms). Vortex structures are shed, which later collapse in the water without creating any damage as they are away from the surface of propeller and hub.

Due to this, it can be argued that cavitation erosion for propeller P2 is mostly ascribed to the continuous collapse of the cavitating sub-structures forming the wedge like assembly, rather than to the collapse of the assembly itself.

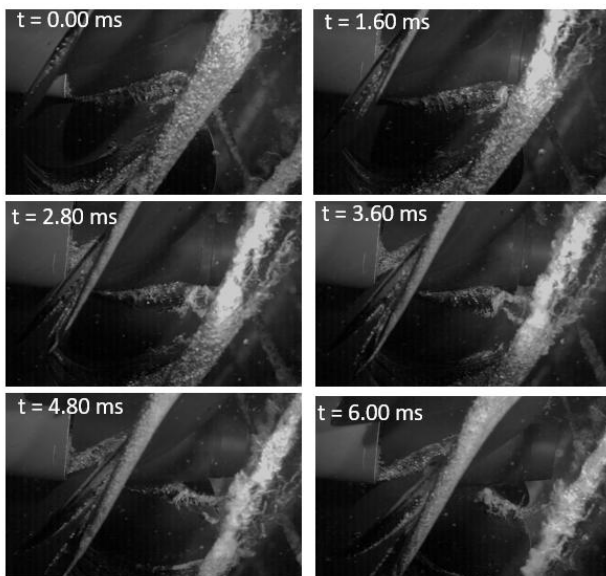
Figure 7. Cavities dynamics (structure, evolution and collapse for P3 Propeller)

Actually, after reaching the maximum extent around 90° , the global cavitation structure contracts violently in all the directions toward a region located approximately at $0.4R$, and $0.4C$, where violent collapse events are observed. During this process, secondary collapses are observed along the outer edge of the wedge like cavity, associated

to the fragmentation of the main cavity during its contraction.

After the collapse of the main cavity, large rebound phenomena are observed, usually forming a rather large cloud cavitation which moves downstream and further collapses almost in correspondence to the trailing edge. The motion of this cloud is characterised by significant spin around a direction almost parallel to the trailing edge, apparently caused by the collapse itself.

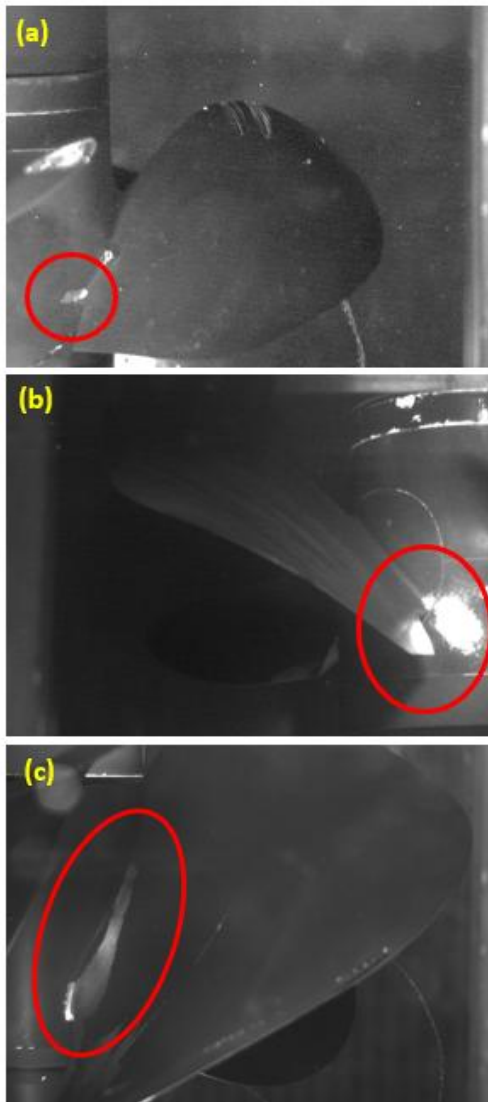
Figure 8(a) shows the suction side of blade root for propeller P1 for one of the blades, highlighting paint removal in these zones. Suction Side root/hub erosion can be seen in the red circles in the images. A consistent damage was observed for all blades, located between the fillet at the root and the surface of the hub, near the trailing edge of the root itself.

The root blade damages on suction side for propeller P2 is shown in Figure 8(b). Suction side damage on the blade root is exhibited in red circle. The damage was near the trailing edge of the blade above the overhang, and on surface of hub below the overhang, and it seems to be consistent for all four blades.

Suction side damages for P3 propeller on the blade root are shown in Figure 8(c). The suction side damage (shown in red circle) started near the mid chord of the blade root extended to the trailing edge root, and forming a streak like structure. The damage at the trailing edge blade root was a bit extended.

Figure 8. Damages on suction observed from CAM1 for (a) P1 Propeller (b) P2 Propeller and (c) P3 Propeller

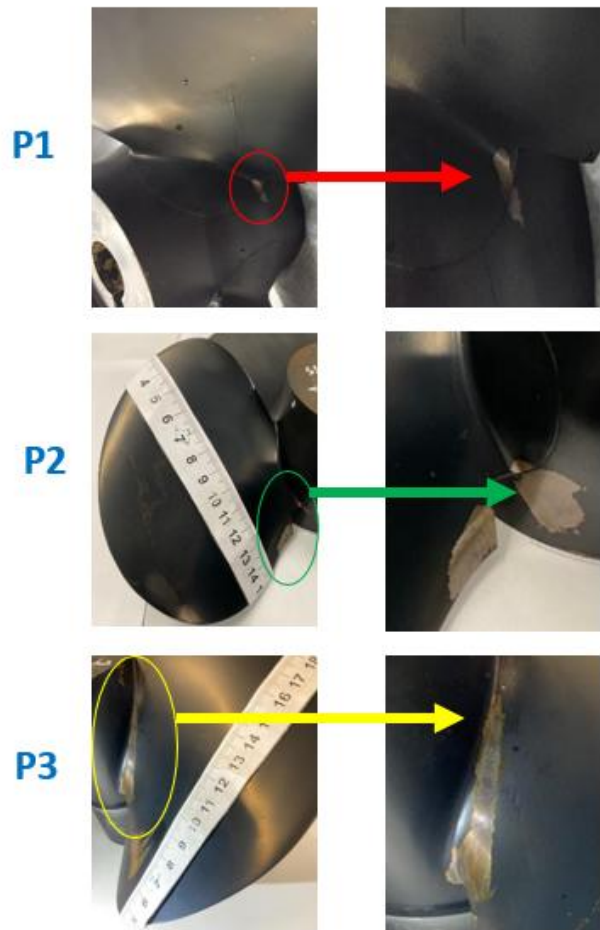
The damage extent on suction side for all propellers with magnified view is reported in Figure 9. For P1, the damage on suction side located on the hub/fillet was around 0.5 cm in length.

Propeller P2 damage on suction side near the trailing edge above the overhang was in the form of a quarter ellipse with major to minor axis ratio of 1 cm to 0.4 cm. The damage on the surface of hub below the overhang was a semi-circular damage of diameter of around 0.8 cm.

Propeller P3 damage on suction side in the streak form has a length of around 5 cm along the root chord. The maximum damage appeared near trailing edge, with a radial extension of about 0.7 cm.

Figure 9. Damages on suction side observed after test for P1, P2 and P3 Propeller with magnified view

The average inception time of suction side root damages for propeller P1, P2 and P3 was 150, 70 and 15 minutes respectively. It can be seen that with increasing extent of cavitation, the inception time has been reduced tremendously. Analogously, the damage area, i.e. the area where paint has been removed, increases significantly from P1 to P3.
