SEISMIC BEHAVIOUR OF ORDINARY MASONRY BUILDINGS DURING THE 2016 CENTRAL ITALY EARTHQUAKES

Sorrentino L., Cattari S., da Porto F., Magenes G., Penna A.

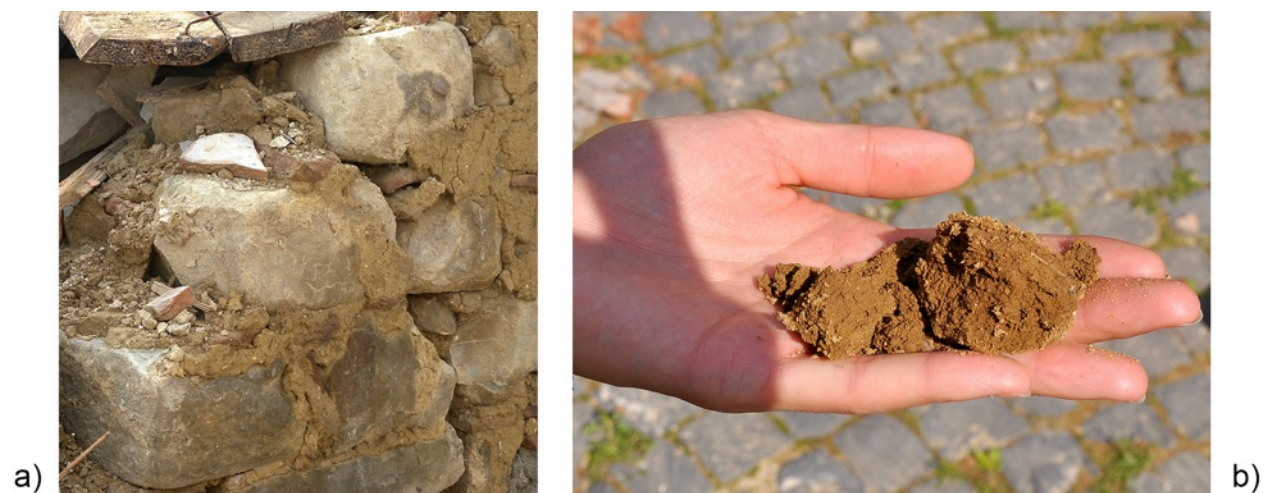
Fig. 5. Mud mortar in: a) Accumoli, Illica, and b) Amatrice, Sant'Angelo.

The earthquake has shown how masonry had two or three unconnected layers across the thickness, units were not dressed and mortar was usually made of mud (Fig. 5). Intermediate horizontal structures were mostly timber structures and, to a lesser extent, jack-arch or I-beam and hollow clay block floors (Fig. 6). Structural vaults were present at ground floor in about one third of the building stock. Ties and/or ring beams were present in just about one fifth of the portfolio, much less than in Norcia (Fig. 3), either as iron wall anchors of timber elements (Fig. 7) or as modern steel rods (Fig. 8). The roof had a timber structure in most cases, but in about one tenth of cases it had been replaced by a reinforced concrete structure. In such instances internal horizontal structures had been usually replaced, as well.

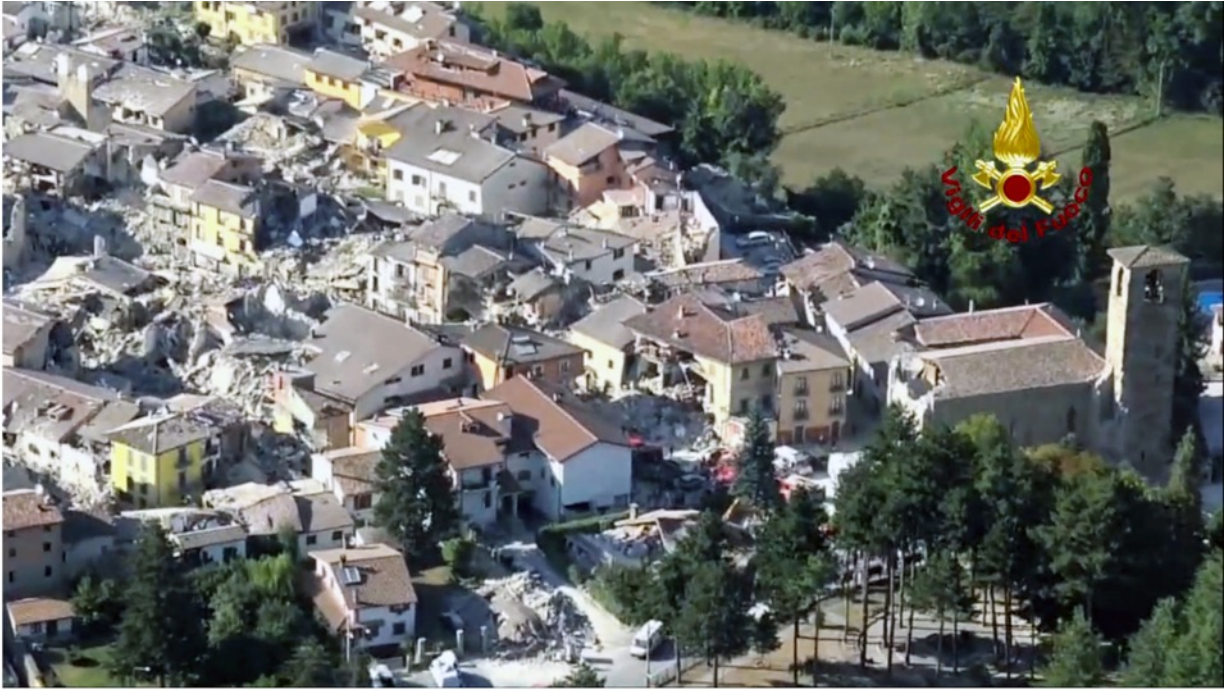
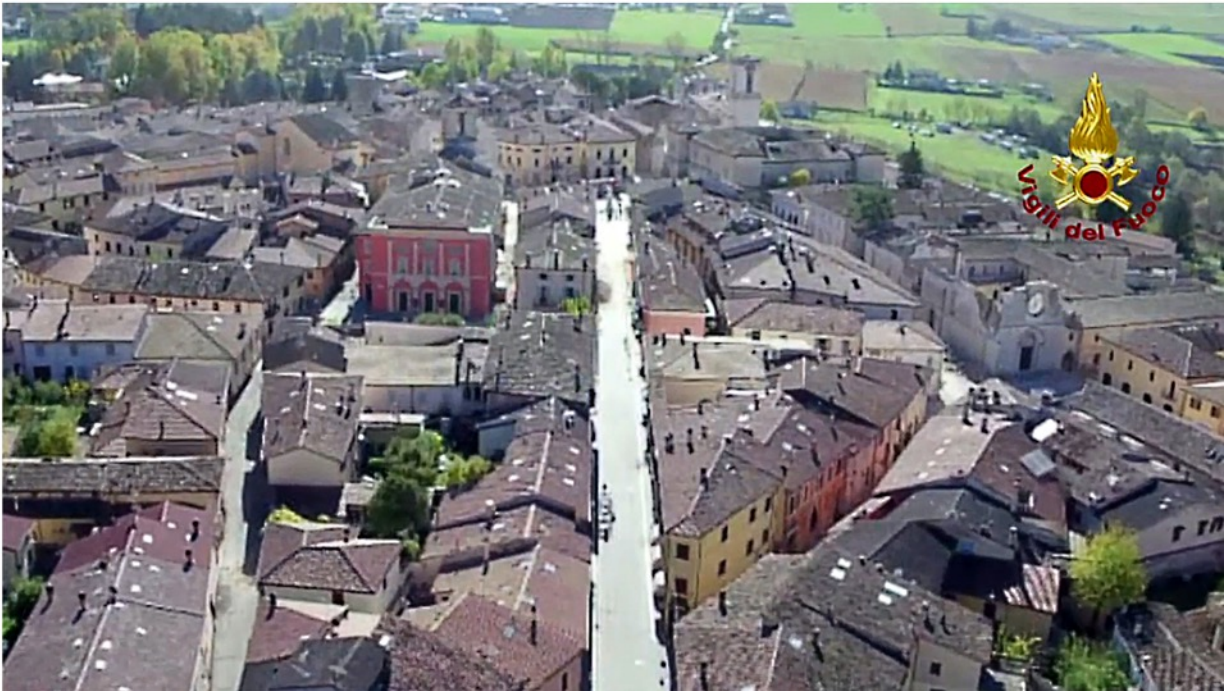
Field surveys in the most affected area have shown catastrophic collapses, with the historical centres of some settlements being almost completely destroyed. However, such dramatic performance was observed in Amatrice (Fig. 9a) and Arquata d/T, whereas residential buildings in the historical centre of Norcia have shown a much better performance (Fig. 9b), despite ground motion being similar or even more severe in the last settlement (Table 1, Fig. 2).

Fig. 9. a) Amatrice, after the 24th August event. b) Norcia, after the 30th October event. Snapshots from the movies released by the Firefighters Corps (www.vigilfuoco.tv).

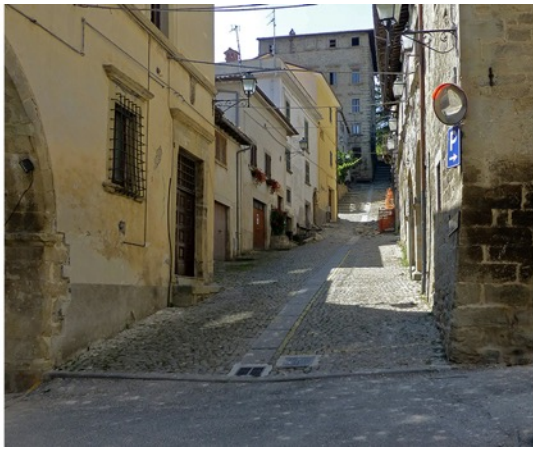
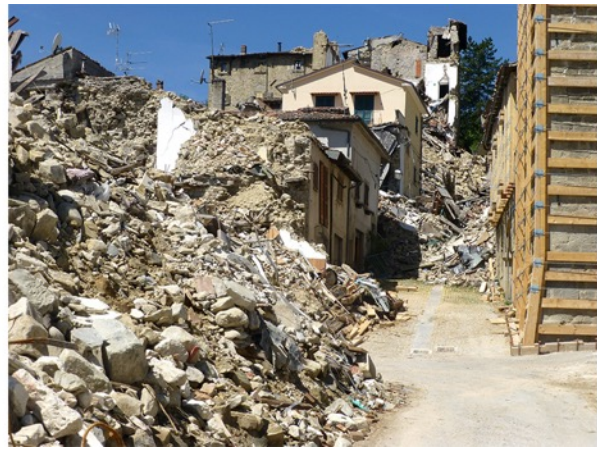
The effect of damage accumulation played a significant role in defining the actual destruction situation of some settlements, although the difference in the quality of structural details and masonry illustrated in § 2 is decisive for the seismic response of buildings to repeated shocks. For instance, being comparable the ground motion experienced in Norcia and Accumoli on the 24th August and the 30th October (Table 1, Fig. 2), the final state is completely different leading to the almost total destruction of ordinary historical buildings in Accumoli (Fig. 10).

Fig. 10. Damage accumulation in Accumoli, via Tito Vespasiano: a) After August 24th, b) After October 30th.

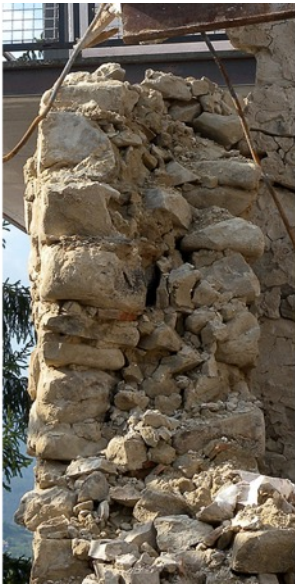
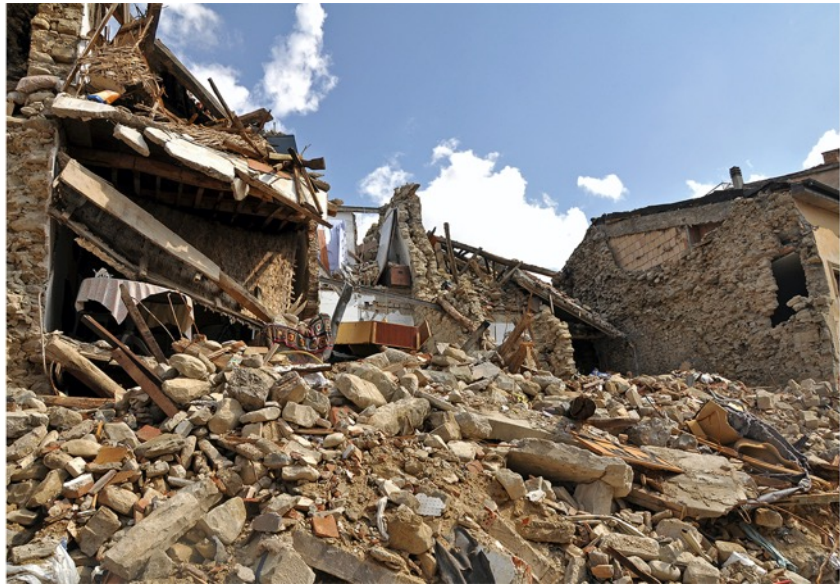
In several cases the main damage mode of the buildings has been the disintegration of masonry, due to a combination of undressed units and very poor mortar quality (Fig. 11). Although delamination of external masonry leaf has been reported in other Italian earthquakes (e.g., Decanini et al. 2004; Augenti and Parisi 2010), it has been extremely common in some settlements of Amatrice, Accumoli and Arquata d/T involving large portions of whole blocks. Therefore, the critical role of mortar has been clearly highlighted by this sequence, with collapses occurring even when the units' assemblage was reasonably accurate at least on the external leaf (Fig. 12), and mortar composition and strength should be always investigated to make an exhaustive assessment (Artioli et al. 2010; Liberatore et al. 2016). Personal communication by an old person in one of the small settlements within the municipality of Amatrice conveyed that at least until 60-70 years ago wall construction took place manufacturing mortar from a soil pit where the excavated ground was mixed with water until proper plasticity was achieved.

Fig. 11. Poor performance of undressed natural stone buildings in: a) Accumoli, Illica and b) Amatrice, corso Umberto I.

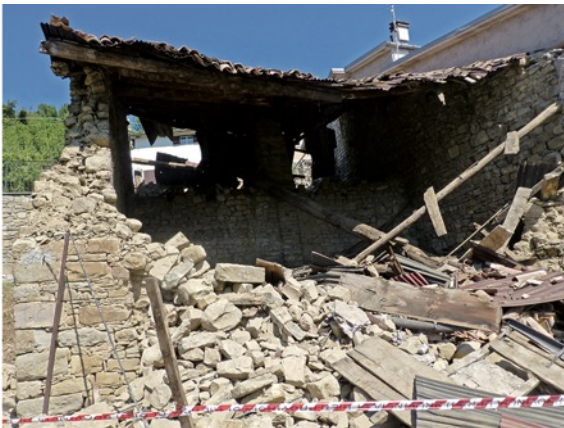
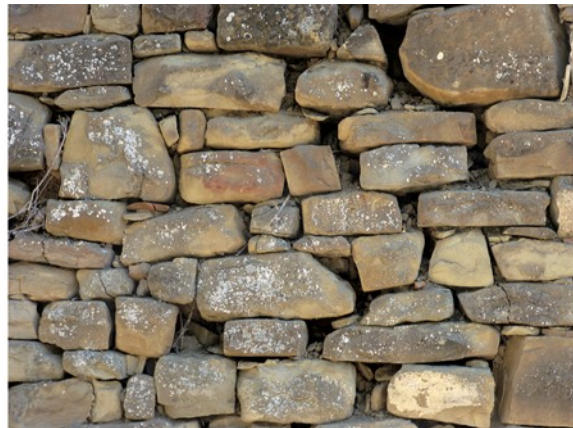
Fig. 12. Masonry disintegration due to poor quality mortar in a reasonably accurate units' assemblage of the external leaf. Amatrice, Cossito: a) Front view, b) detail of masonry on the left-lateral wall.

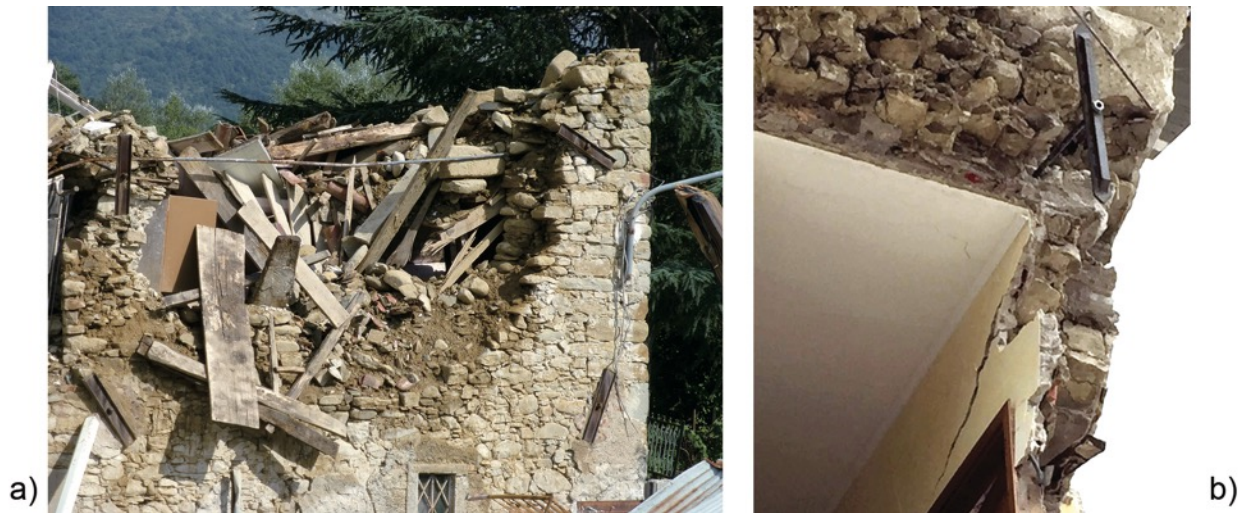
Fig. 13. Collapse of a masonry building having steel ties combined to poor mortar. a) Amatrice, Petrana; b) Arquata d/T, Piazza Umberto I.

If disintegration due to poor masonry quality occurs any modelling of building response becomes unreliable (Sorrentino et al. 2017). As shown in Fig. 13, when masonry has such a low strength even the systematic use of steel ties is ineffective. When combined with a reasonable quality masonry, steel ties certainly contributed to preventing collapse (Fig. 3, Fig. 8). Nevertheless, besides the low masonry quality, the limited presence of connections in many buildings, the reduced strength of lateral walls compared to large-units wall intersections (Fig. 14), as well as the presence of intermediate floors having scarce diaphragm effect, poor details at the bearings, and no connections to the walls parallel to beams, should be recalled (Fig. 6).

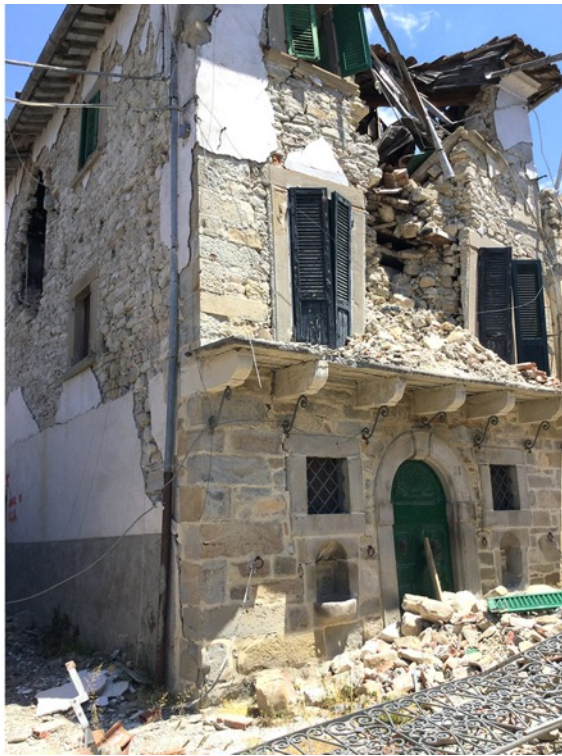
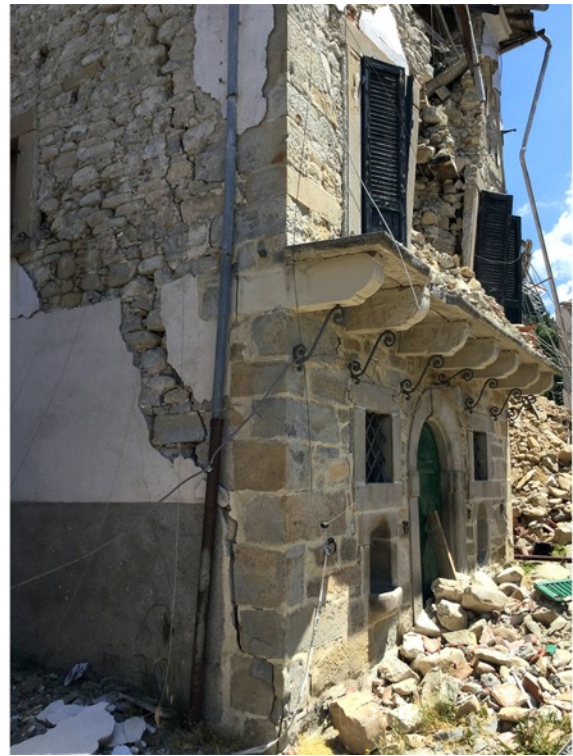
Fig. 14. Reduced strength of lateral walls compared to large-units wall intersections, Amatrice, Retrosi.

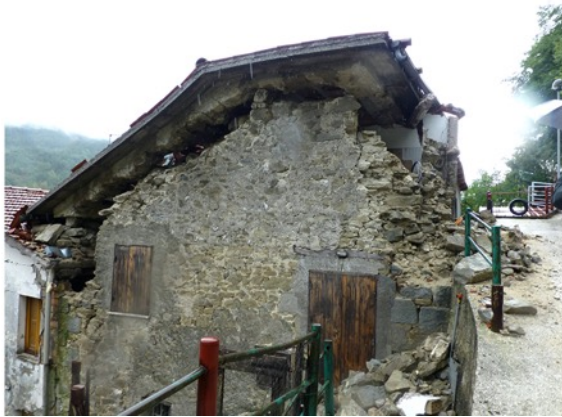
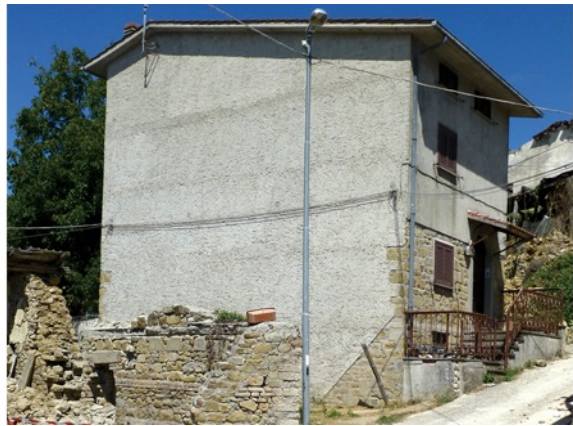
Fig. 15. Replaced reinforced concrete roofs: a) Arquata del Tronto, Pescara del Tronto; b) Amatrice, San Tomasso.

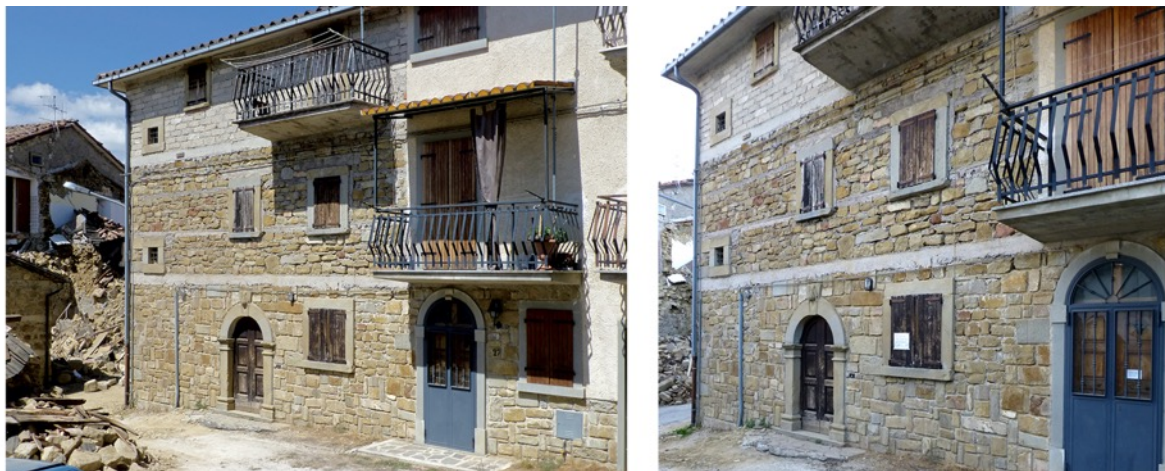
A more radical building activity is that highlighted by the structure in Fig. 17, which has been completely demolished around 1985 and rebuilt using the same natural stone units but a modern mortar. To the satisfactory earthquake performance certainly contributed the ring beams, present at each floor and at opening height at the first storey, but the lack of evident damage suggests an adequate strength of the stonework as well.

Fig. 17. Demolished and rebuilt natural stone masonry, resorting to modern mortar and ring beams. Amatrice, San Capone. a) Post 24th August; b) Post 30th October.

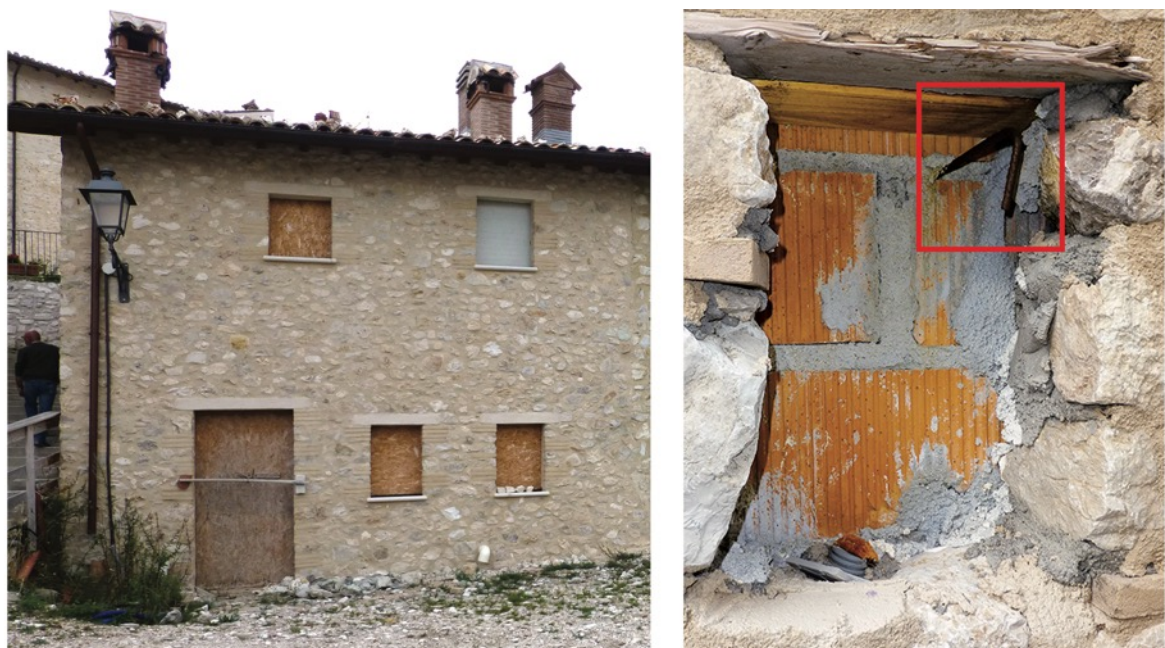
Demolition and reconstruction has been observed also in other instances. In Castelluccio di Norcia the building in Fig. 18a presents a natural stone masonry veneer. However, the actual structure is made of hollow clay blocks, as visible in a local gap (Fig. 18b), as observed also in Montegallo and as documented by a previous research on another building damaged by the 1979 earthquake (Binda et al. 2005). The building in Fig. 18 has survived undamaged the August events and despite a second inspection was impossible because the whole historic centre has been made off limits, aerial views after the October events showed that it still stands. The veneer is connected to the blockwork by means of carbon steel rebars (Fig. 18b), which proved effective in the current seismic sequence occurred just after construction, but could be corroded over time. Hence, stainless steel reinforcement is to be recommended.

Fig. 18. Demolished and rebuilt clay block masonry with connected natural stone veneer. Norcia, Castelluccio di Norcia. a) General view, b) close up of a cavity, with clay block and connection rebar visible within the red frame.

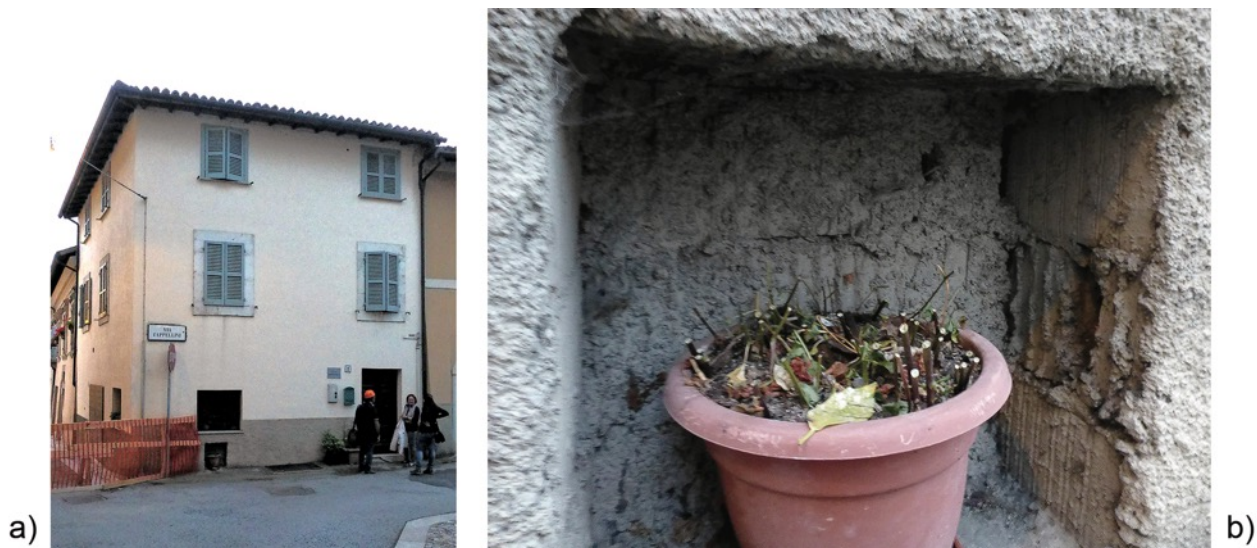
Fig. 19. Demolished and rebuilt plastered clay block masonry. a) General view, b) close up of a cavity, with clay block visible. Norcia, via Anicia intersection with via Cappellini.

A somewhat similar example is that in Fig. 19a, located in the very historical centre of Norcia. The building seems a typical vintage construction, but its plaster finishing covers a hollow clay block structure (Fig. 19b) as a result of a mid 1980s demolition and reconstruction. Interventions such as those just documented have been considered in the past as unacceptable, but the extremely poor performance of entire historical centres and the very high toll in terms of lost human lives suggest that a general reconsideration is necessary. Preservation of environment values (shape and surface aspect of the buildings), while internal structure is replaced, should not be considered out of question, both in the case of collapsed buildings as in the case of documented very poor characteristics of masonry in slightly damaged buildings.

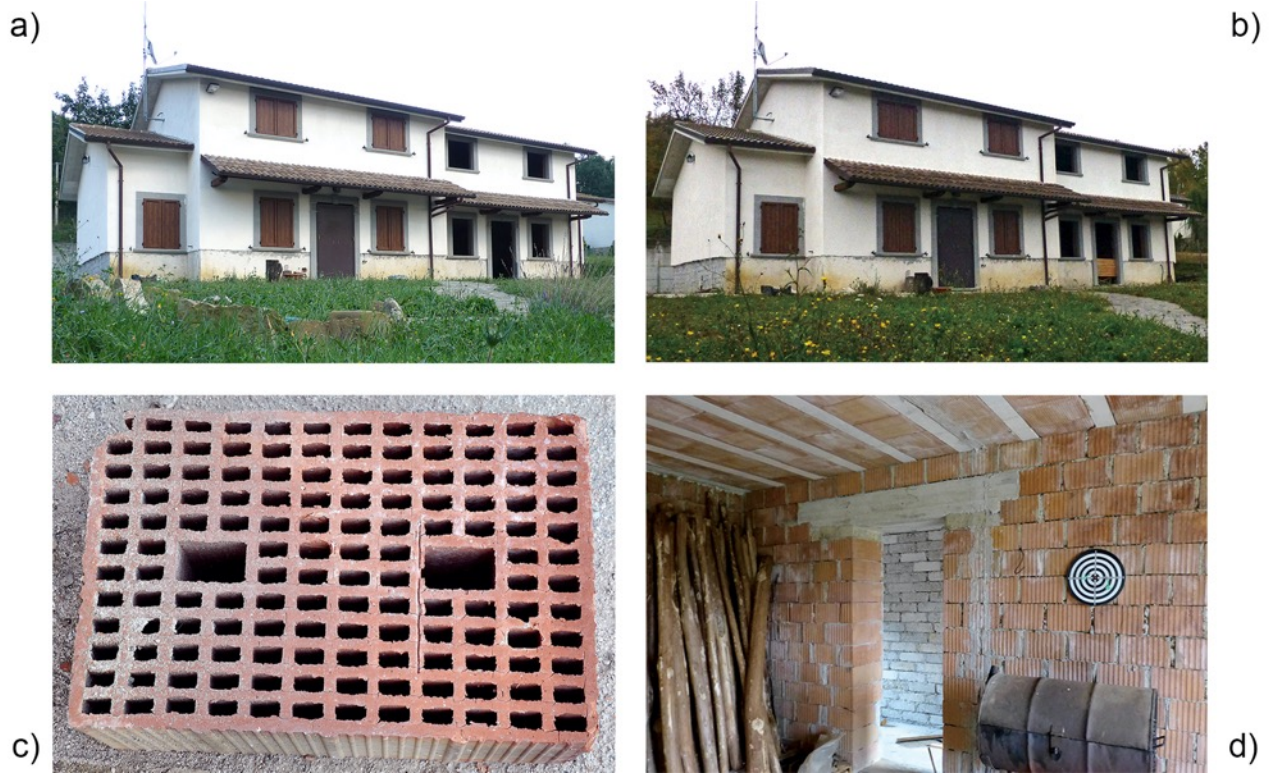
Fig. 20. Clay block masonry building. a) After the 24th August event, b) after the 30th October event, c) close up of a block, d) view of bare wall and floor. Amatrice, San Capone.

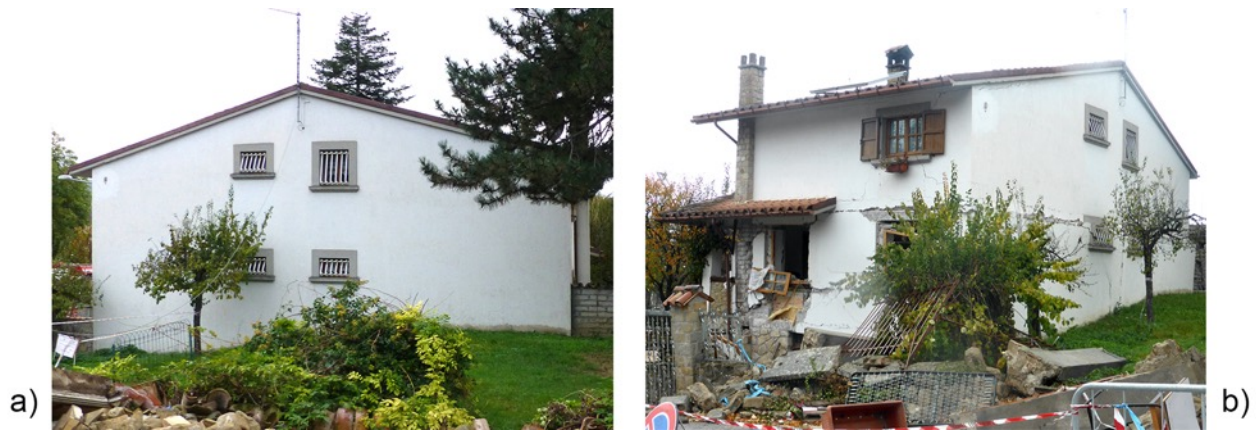
Fig. 21. Solid concrete block masonry building. a) After the 24th August event, b) after the 30th October event. Amatrice, viale Saturnino Muzii.

Although hollow clay blocks are the most used units in the last years, other solutions have been resorted to in the recent decades. An example is given by solid concrete units visible in the top floor of the house in Fig. 17, as well as in the building adjacent to Amatrice historical centre in Fig. 21. This last building, dating back to the mid 1980s, has 600 mm thick walls in the basement, 450 mm walls at ground floor, and 300 mm walls at first floor. It survived the August events without any damage, despite the widespread collapses of nearby standing structures. The October events, on the contrary, caused a heavy rocking response in the piers of the ground floor and moderate shear cracking at the first floor. Overall the performance can be certainly considered code compliant, bearing in mind the severity of the shaking in Amatrice. Similar success histories have been observed in Accumoli and Casale (municipality of Amatrice), whereas in San Lorenzo a Flaviano and Saletta (municipality of Amatrice) performance has been much poorer.

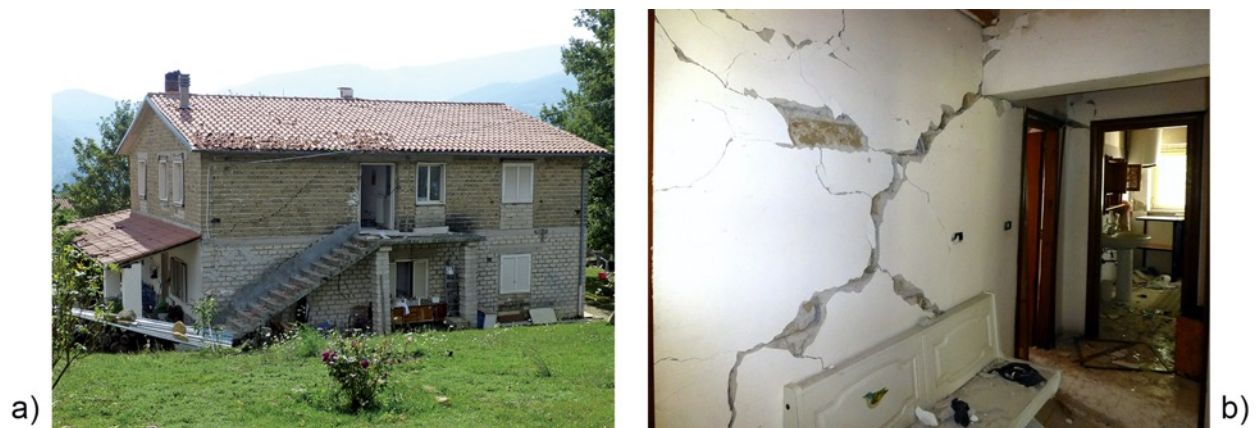
Fig. 22. Solid concrete block masonry (ground floor) and tuff masonry (first floor) building. a) External view, b) Internal view at first floor above ground. Accumoli, Illica.

In Illica there is a modern masonry building, having a ground floor made of solid concrete units, and a top floor made of tuff solid blocks (Fig. 22a). Whereas the bottom floor survived the August events with just slight damage, the top storey suffered heavy stair stepped shear cracks (Fig. 22b). This response seems to indicate that mortar had a lower strength of stone units, but the overall performance is still acceptable although less satisfactory of that of the concrete block masonry at ground floor, which is also usually where in plane seismic demands are higher. A better response in a tuff masonry construction has been observed in Accumoli and a somewhat worse in Saletta (municipality of Amatrice), but again without unit cracking and without any collapse.
