SLOW-MOVING LANDSLIDE DAMAGE ASSESSMENT OF HISTORIC MASONRY CHURCHES: SOME CASE-STUDIES IN ITALY

CHIARA FERRERO^{1,2*}, LUDOVICA CAMBIAGGI¹, ANDREA FENIALDI¹, PERE ROCA², RITA VECCHIATTINI³ AND CHIARA CALDERINI¹

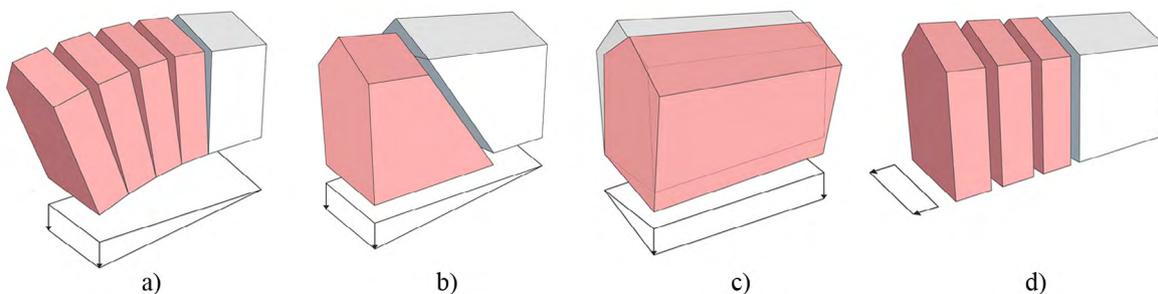
Figure 1: Global damage mechanisms identified in [1]: a) Hogging, b) Shear deformation, c) Global rigid rotation, d) Extension.

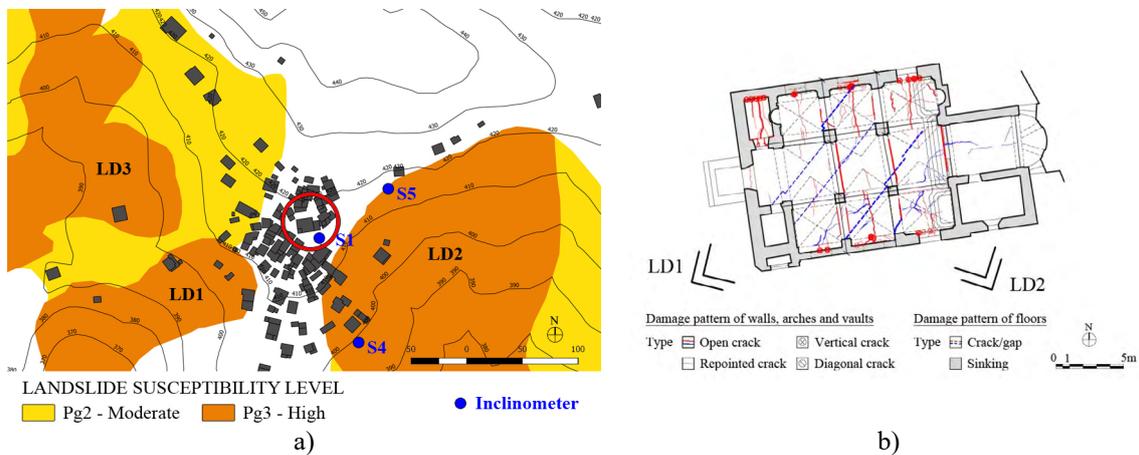
Figure 2: San Martino church in Cembrano: a) position of the church and inclinometers on landslide maps, b) damage pattern.

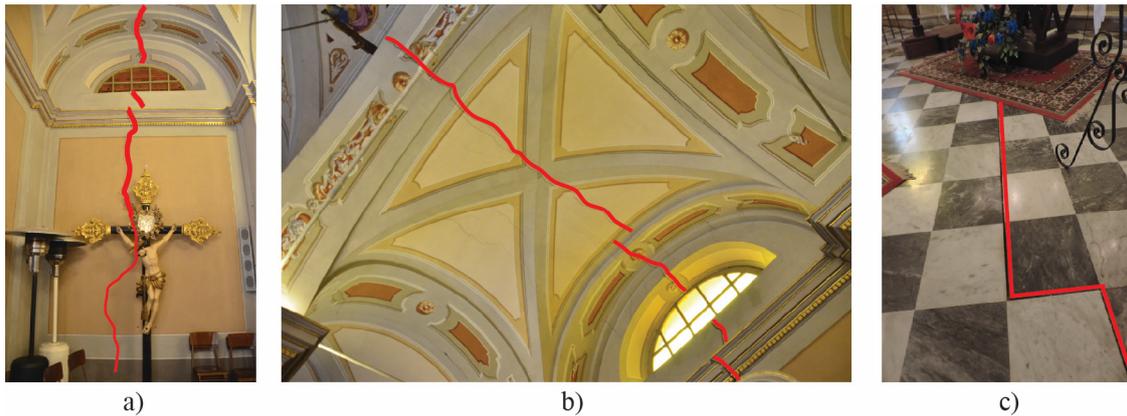
Figure 3: Damage observed in San Martino church in Cembrano: a) vertical cracks in the longitudinal walls, b) cracks continuing up into arches and vaults, c) parallel oblique gaps in the floor.

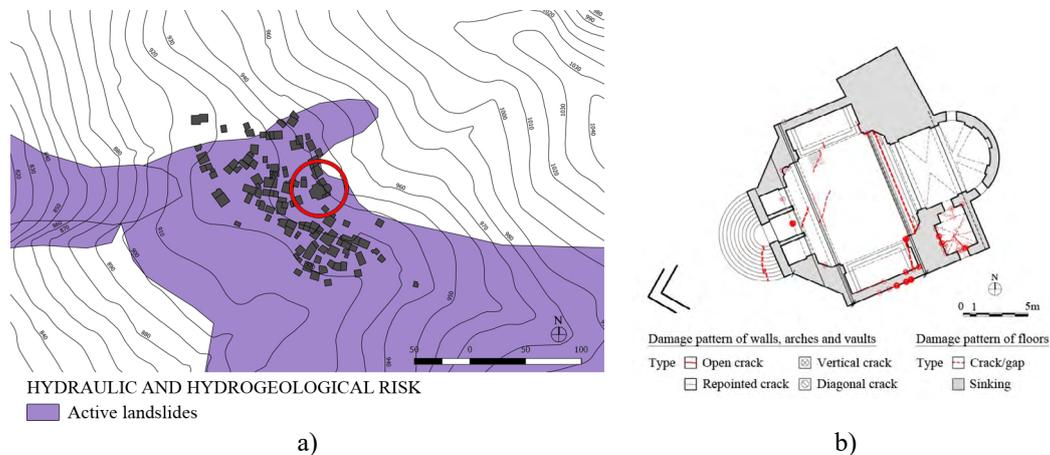
Figure 4: San Bernardo da Mentone church in Ascona: a) position on landslide maps, b) damage pattern.

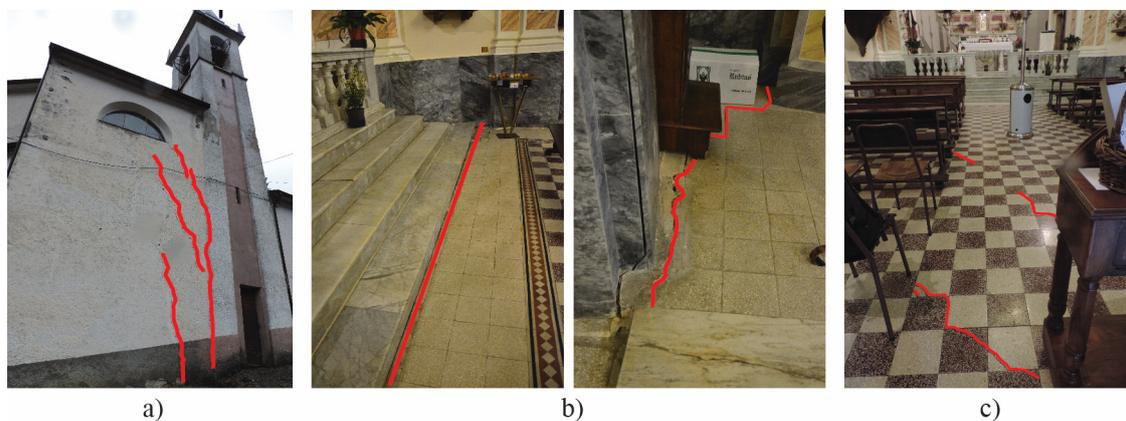
Figure 5: Damage observed in San Bernardo da Mentone church in Ascona: a) diagonal cracks in longitudinal walls, b) large gap/crack in the floor, c) parallel oblique cracks in the floor.

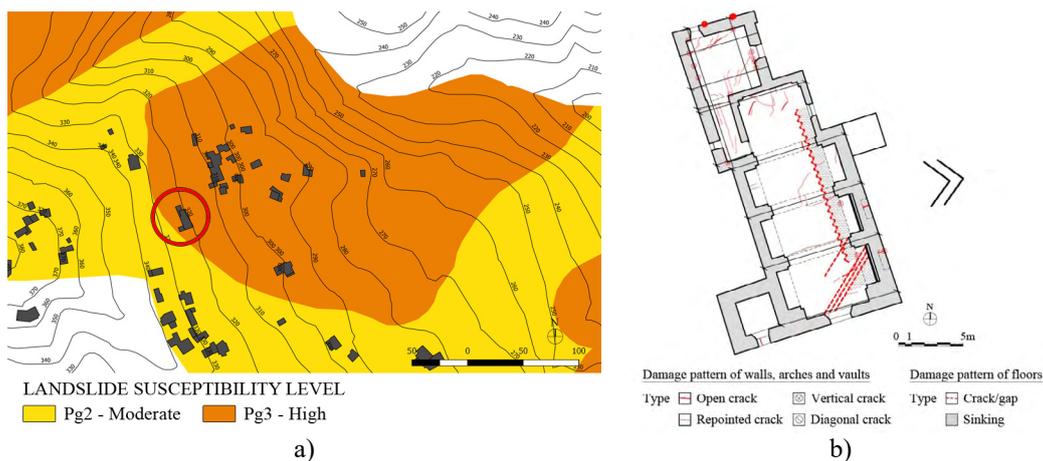
Figure 6: San Lorenzo church in Sorbolo: a) position on landslide maps, b) damage pattern.

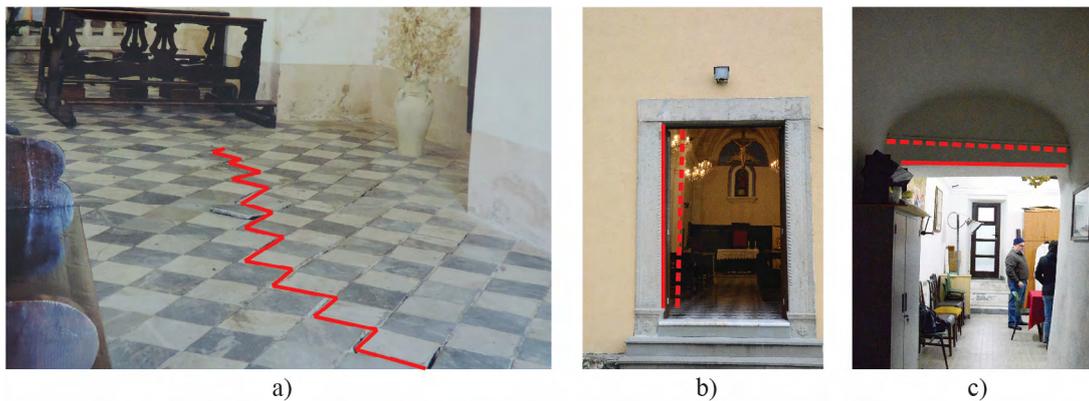
Figure 7: Damage observed in San Lorenzo church in Sorbolo: a) saw-tooth longitudinal gap and sinking, b) out-of-plumbness of longitudinal walls, c) distortion of transverse arches and loss of horizontality of tie-rods.

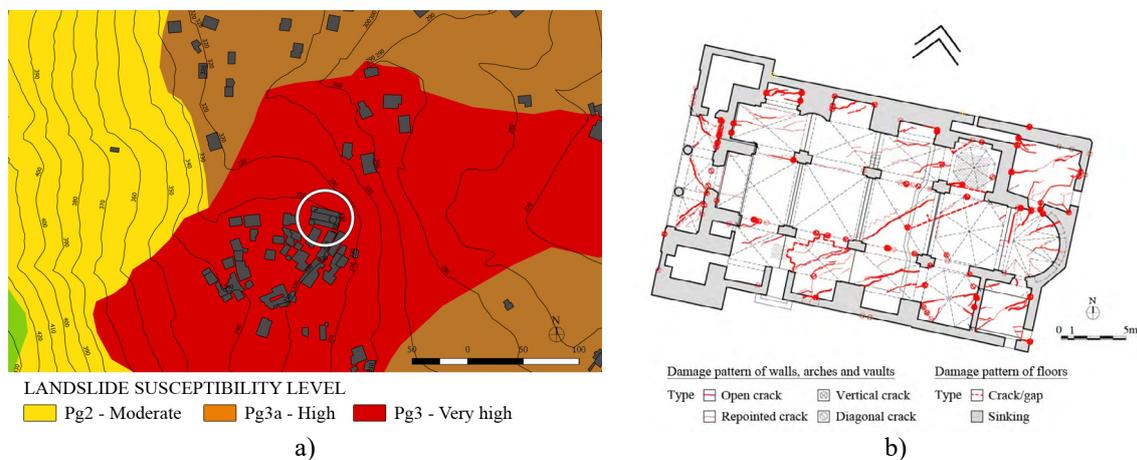
Figure 8: Santa Margherita church in Diano Arentino: a) position on landslide maps, b) damage pattern.

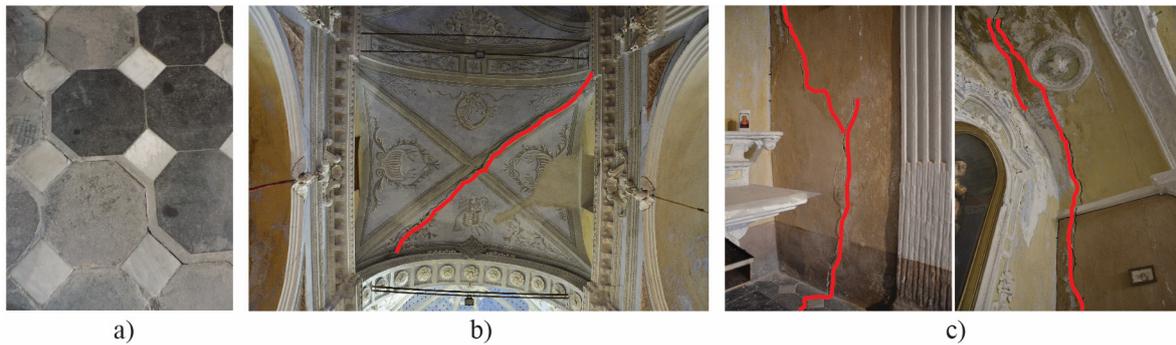
Figure 9: Damage observed in Santa Margherita church in Diano Arentino: a) large gap in the floor, b) diagonal shear cracks of vaults, c) vertical crack progressing over the entire height of the wall from floor to vaults.
