HISTORIC STRUCTURES FRAMED WOOD IN LIGURIA. UNDERSTANDING DIAGNOSIS, PRESERVATION

Keywords: Structures-framed wood, Architecture, Conservation, Liguria, Cultural Heritage

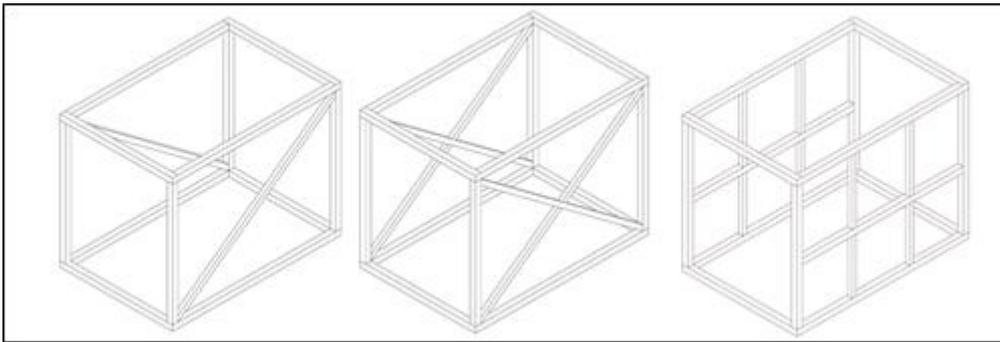
Most common secondary load bearing structures taken from the Experimental Sheet

- The secondary load bearing structure, that is the strut or St. Andrew’s cross, specifying the material and the localization in relation to the load bearing sistem.

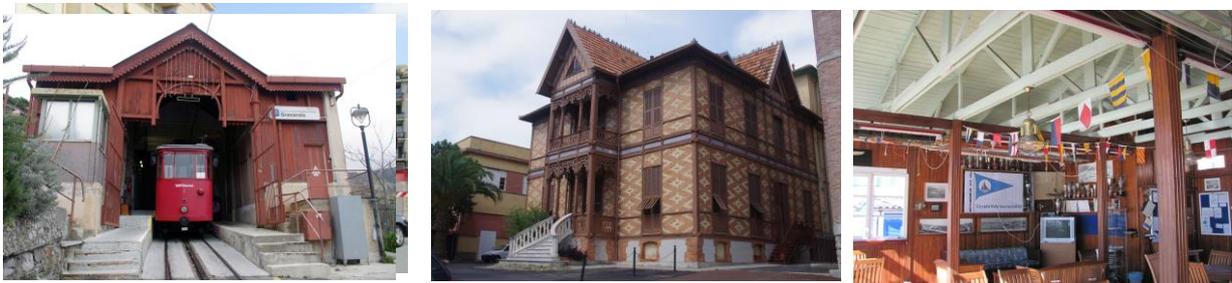
Pictures in order from left to right: *the funicular wood's terminus, eExample of residential building, sample of bathing establishment, the "red house" an ex warehouse, railway warehouse in Pontedecimo station, Survey with Pylodin Hamm, Test with Hydrometer.*
