# State of Conservation of Concrete Heritage Buildings: A European Screening

**Keywords:** assessment; concrete; damage processes; decay patterns; historic structures

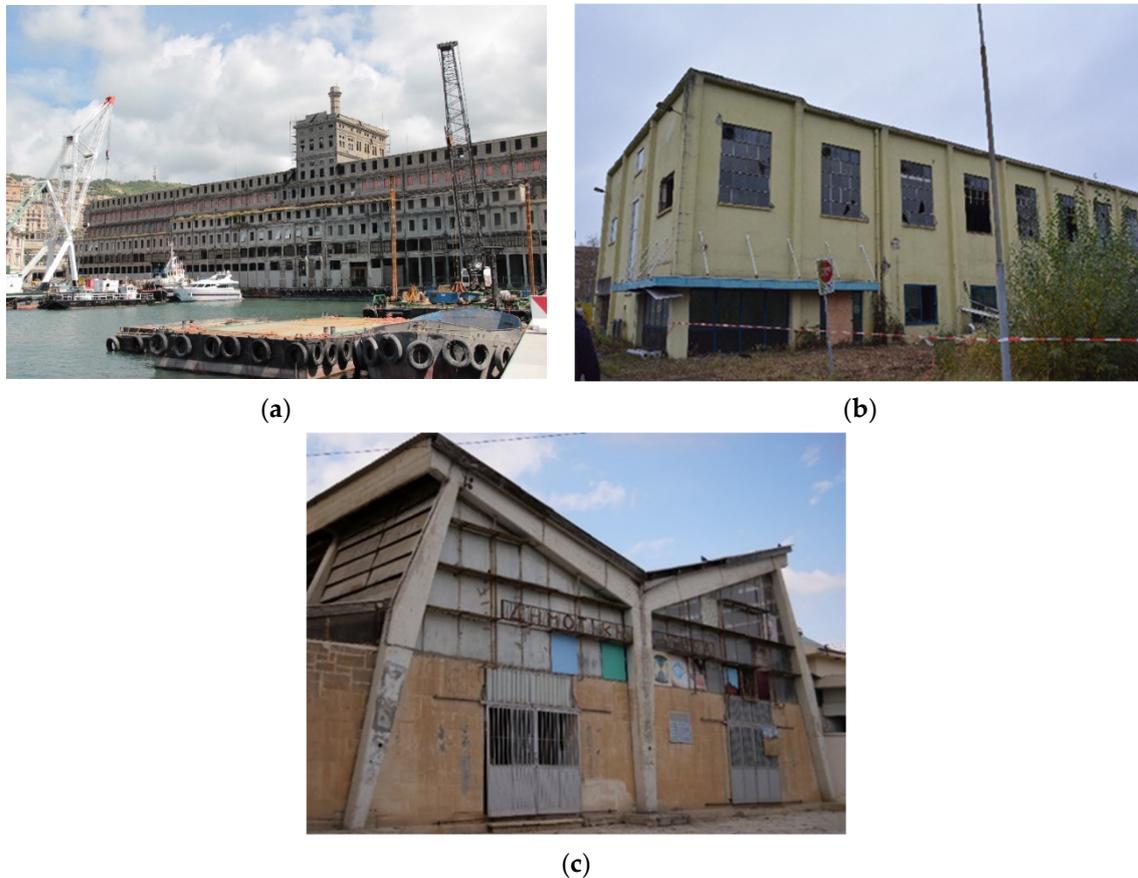
**Figure 1.** Historic concrete buildings. (a) Hennebique Silos in Genova (1901–1906). Source: Authors 6; (b) Calve Building (1908) in Delft, the Netherlands. Demolished in 2019. Source: Author 1; (c) Athienou Municipal Market (1951–1955) in Cyprus. Source: Authors 3 and 4.

Reinforced concrete (RC) started to be used in Europe in the late 19th and early 20th centuries. The new material was eagerly adopted in some countries to construct new buildings; whereas in others, concrete boomed in a later period. In Genova, Italy, for instance, the Hennebique silos (1901–1906) (Figure 1a) exhibited an early mastery in the use of concrete systems in a large-scale building with a system patented nine years before [1]. Whereas, in the same period, in the Netherlands, RC buildings tended to be of less entity and complexity like the Calve building in Delft (1908) (Figure 1b) as concrete had not yet found its niche in the country.

island's independency from the British Empire, when the concrete 'boom' started with the construction of many private and public buildings (Figure 1c).

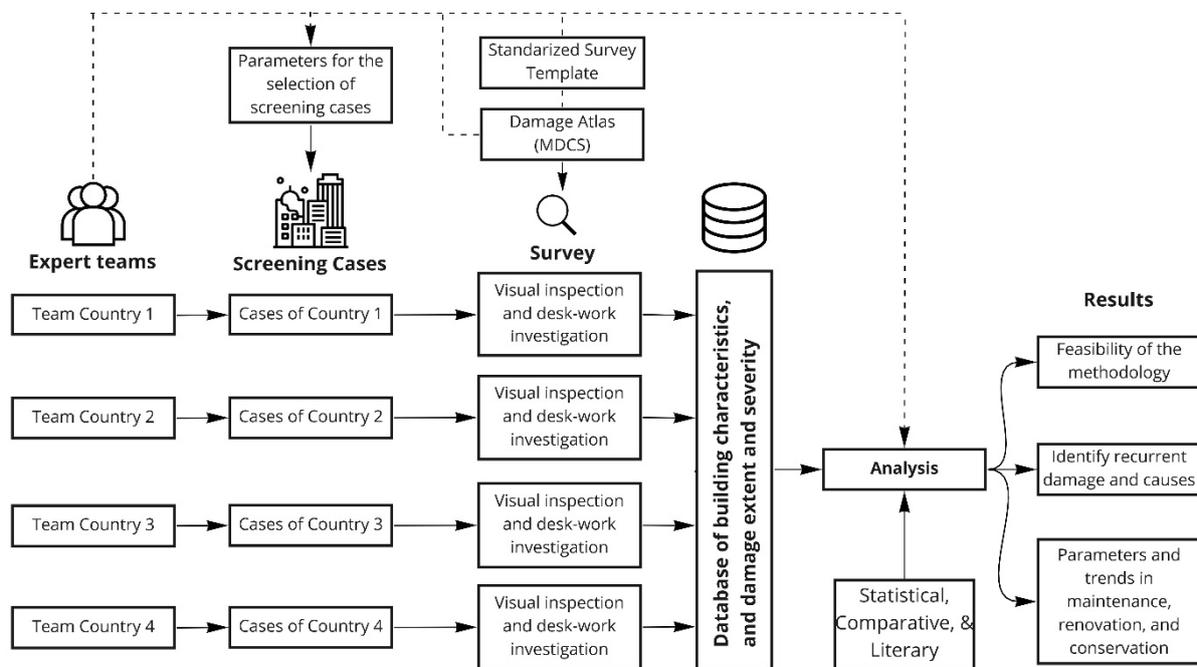
Figure 2. Flow chart of the proposed methodology.

A scheme of the methodology can be found in Figure 2. The survey for each building was carried out by a designated team in each country. Each team was specialized in damage assessment, conservation, and concrete degradation. Starting from the visible damage, each team recorded the most common damage types and evaluated the possible cause(s) of each damage. For this task, the Damage Atlas of the online tool MDCS was used [9], which defines illustrative examples and explains the characteristics and plausible causes of the different damage types.

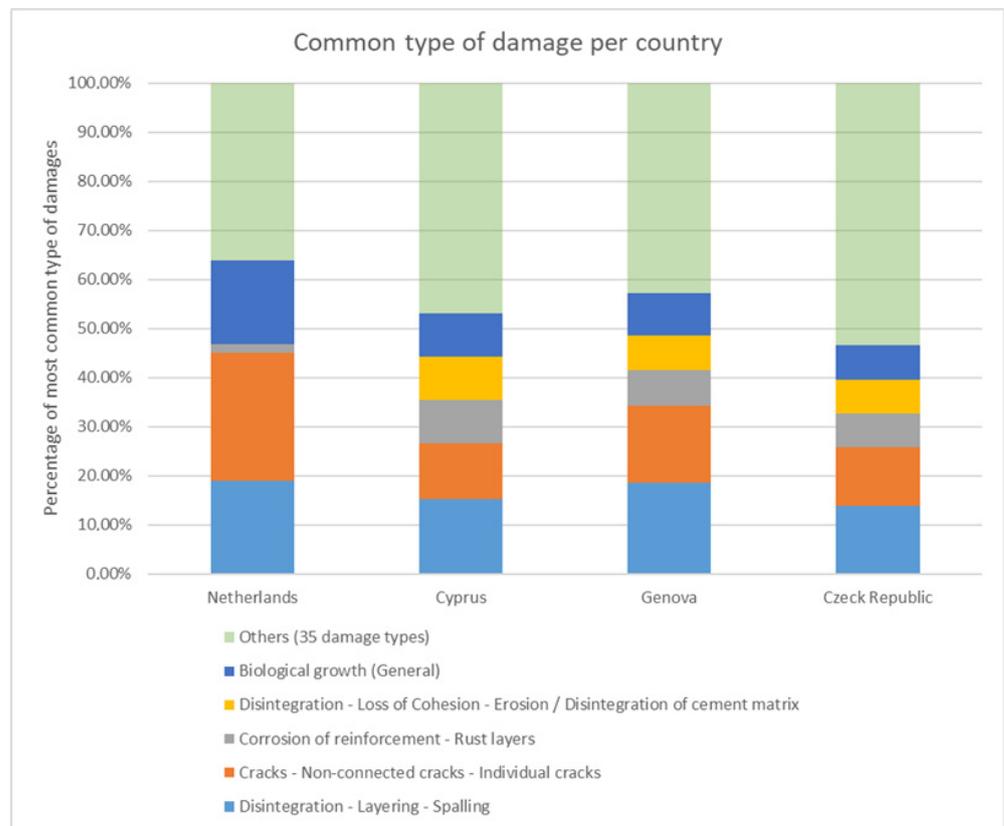
Figure 4. Damage types per country.

Among the types of damage defined for concrete in MDCS (Figure 3), the most recurrent ones were: spalling and delamination (16.42%), individual cracks (11%), corrosion of reinforcement-rust layers (8%), disintegration of cement matrix (6%), and biological-growth-related damages (discoloration and moist spots, 3.85% each). These five types of damages formed around 50% of the damages found across the countries, although the orders of magnitude have slight variations as shown in Figure 4.

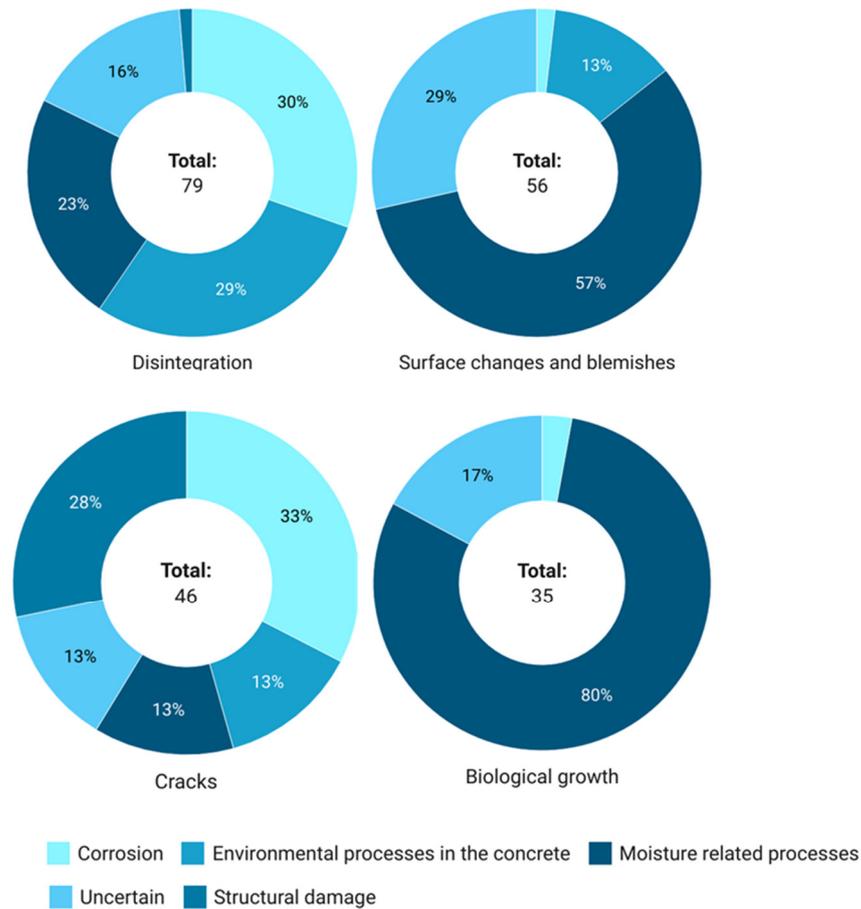
Figure 5. Hypothetical causes of damage per type of damage group.

The correlation between the damage and the potential cause/s is summarized in Figure 5. The most relevant results were that Cracks were predominantly related to corrosion and structural damage, and Disintegration was primarily linked to corrosion, moisture, and environmental processes. The rest of the correlations did not provide significant findings.

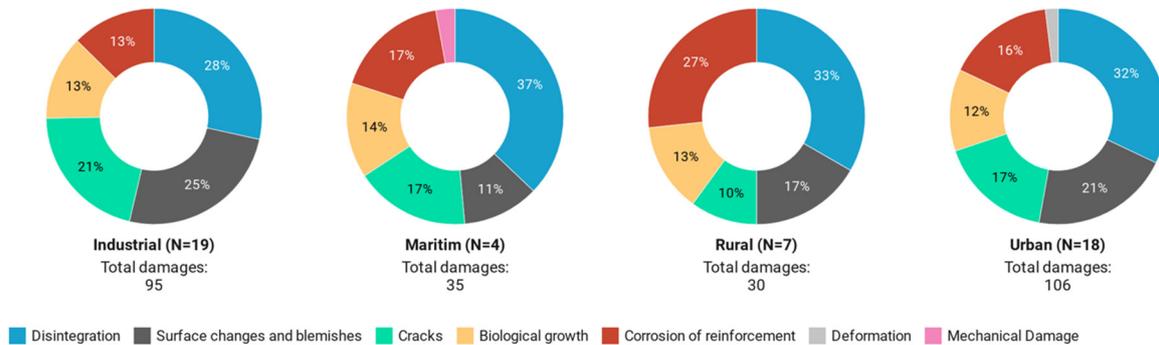
**Figure 6.** Types of damage per environment.

The environment is believed to be one of the leading causes of concrete degradation [15]. This non-physical characteristic was also studied by comparing different environments. Buildings in urban areas showed more extent and severity of damage than buildings in industrial areas (refer to Table 3). The highest severity of damage was found in buildings in maritime areas, although the number of buildings was limited to only three. A relation was also expected between specific types of damage, depending on the environment. However, the relative distribution of the types of damage was similar across all environments studied (refer to Figure 6). Disintegration was the most common damage,

followed by surface changes and blemishes in most environments. Corrosion, cracks, and biological growth appeared in lesser numbers.

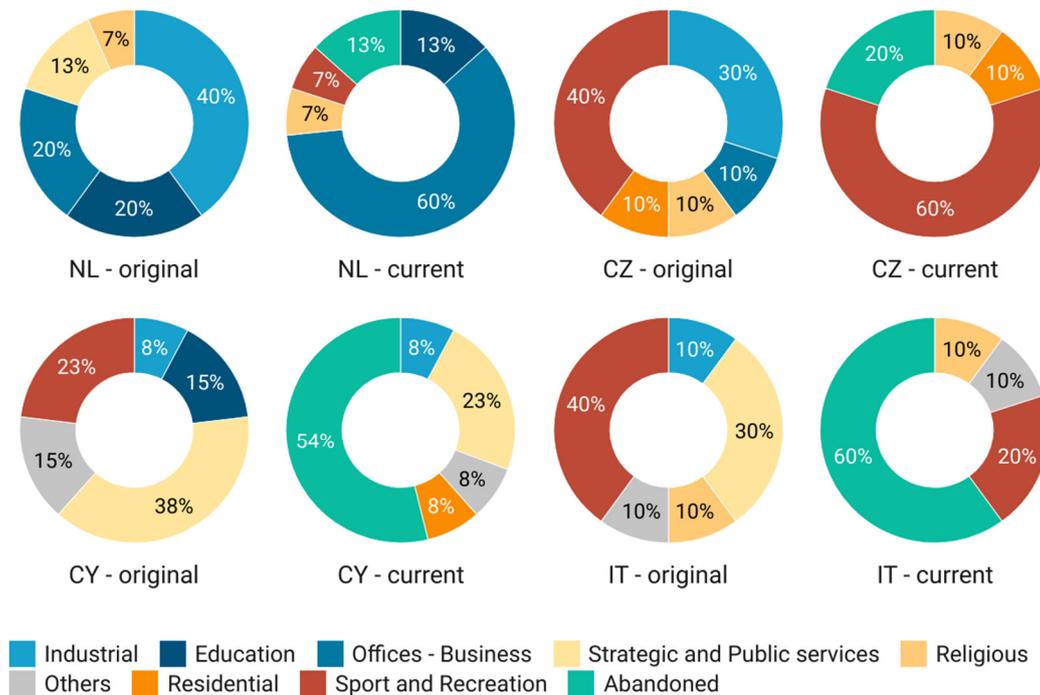
Figure 7. Change of building use per country.

Whether the building had changed its original use or not did not have a noticeable impact on the state of its conservation. Most of the industrial buildings had been converted or abandoned. Educational and Sport and Recreational buildings have been abandoned in Cyprus (CY). In Genova (IT), the only buildings that did not fall into abandonment were religious and “others” (Figure 7).

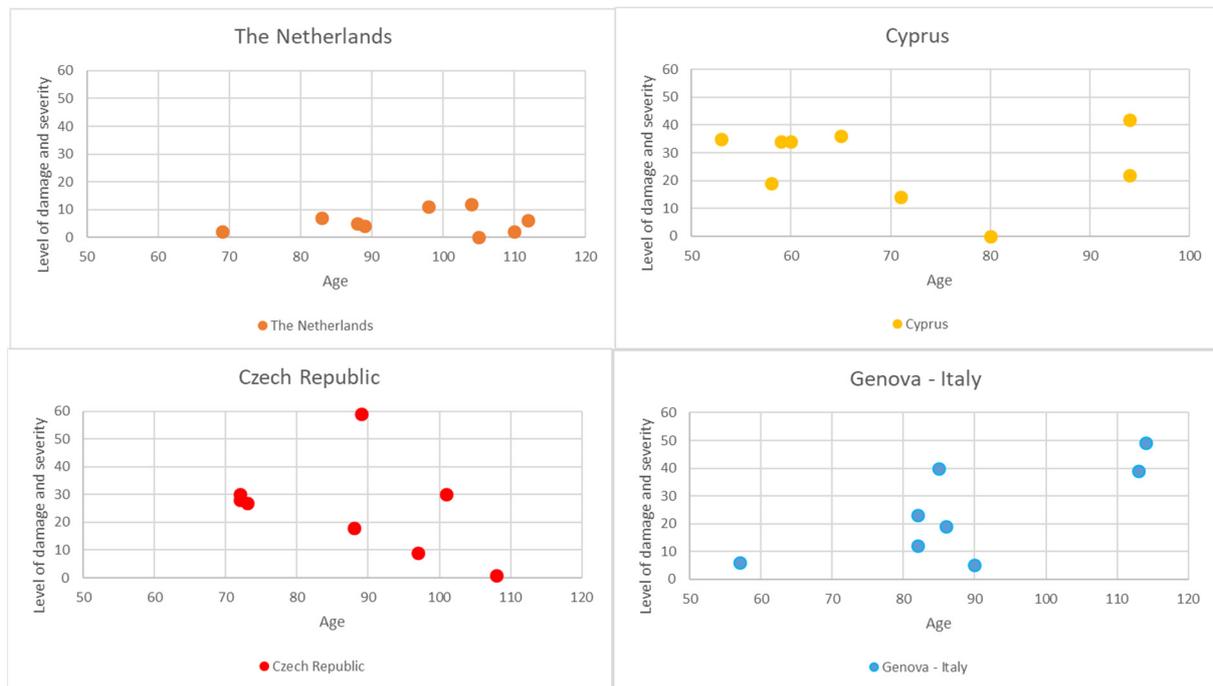
By comparing the state of conservation of non-restored buildings, a trend in building maintenance could be observed among countries. In Figure 8, the non-restored buildings of each country are displayed in terms of Age (X axis) and Level of damage extent and severity (Y axis). The large scatter of the results does not allow for precise conclusions, but some trends can be extracted. Buildings in the Netherlands showed a better state of conservation, having the lowest level of damage across all ages. Cyprus had, on average, higher damage—even in younger buildings. The Czech Republic had scattered results but there seems to be a tendency for a better state of conservation of older buildings. On the contrary, Genova had an opposite trend, where the younger buildings were in a better state than older buildings.

Figure 8. Age (X axis) and Level of damage (Y axis) of the non-restored buildings in each country.

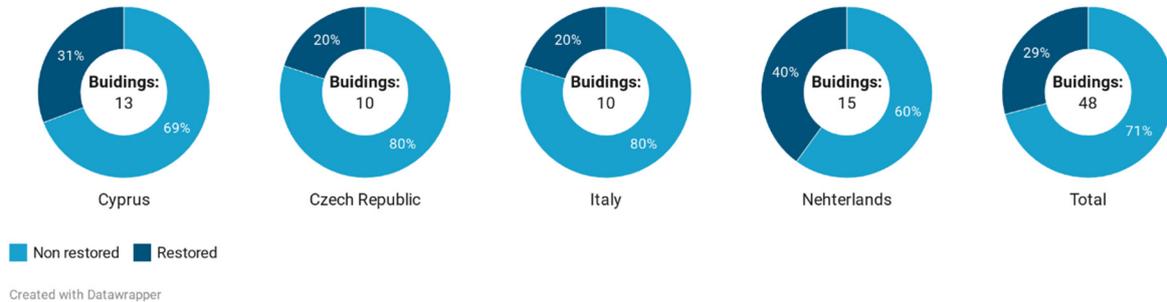
Figure 9. Restored and non-restored buildings per country.

Non-restored buildings accounted for 71% of the buildings studied, showing a similar percentage (from 60 to 80%) in all countries (Figure 9). As expected, restored buildings showed a lower level of damage severity than non-restored buildings.

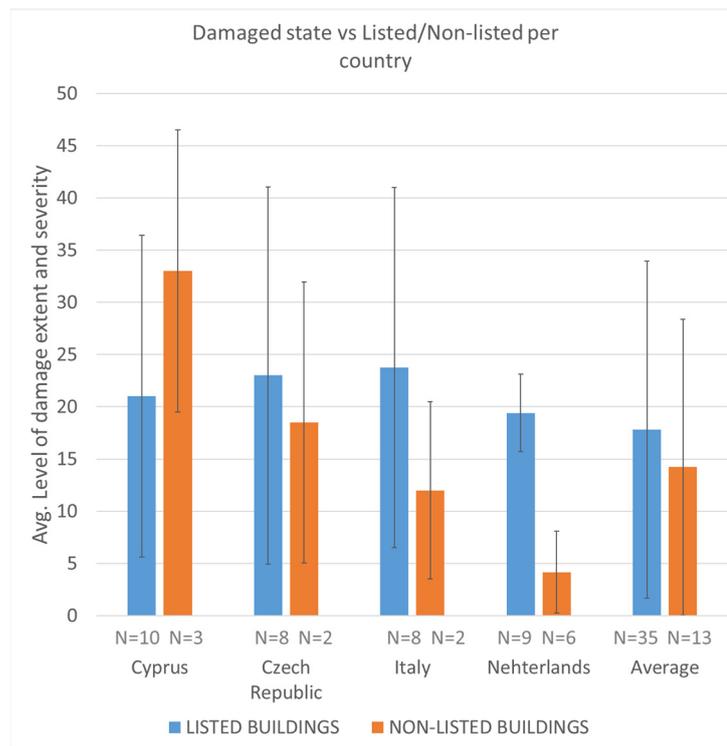
Figure 10. Level of damage severity vs. Building protection per country.

On average, 73% of all buildings had some type of monumental protection. The protection could be local, provincial, or national. Interestingly, the level of damage severity was higher in listed buildings, compared to non-listed, in all countries except Cyprus (Figure 10).

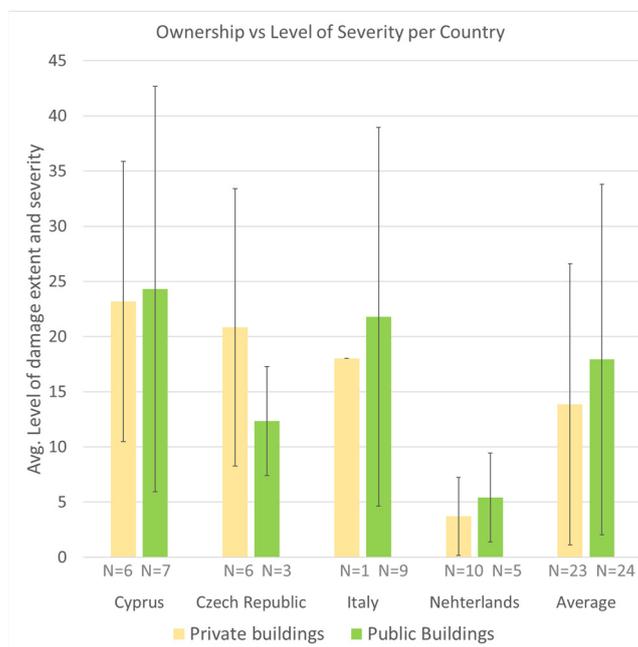
Figure 11. Level of damage severity vs. type of ownership per country.

Generally, there is an even number of private and public buildings in the sample, although there are significant differences in their state of conservation among countries. Considering all the buildings, restored and non-restored, the Netherlands and Czech Republic have similar ratios, 67–33% and 60–40% ratios of private–public buildings, respectively. On the contrary, the buildings in Genova were predominantly public ones (90%). Cyprus had an even ratio, 46–54% of private to public buildings. There is not a clear indication between the level of damage and the ownership; although, private buildings tend to be in a better condition than public ones (Figure 11).
