Modelling of two damaged unreinforced masonry buildings following the Canterbury earthquakes

2016 NZSEE
Conference

ABSTRACT: The reported study focused on modelling the seismic response of two URM buildings that were damaged in the Canterbury earthquake sequence. Static and dynamic nonlinear analyses were undertaken using the equivalent frame approach. Actual time-history records attained during the earthquakes were used to undertake dynamic analyses and facilitate direct comparison to the observed building damage. The results showed that use of the equivalent frame method enabled prediction of the seismic response of the two case study buildings with a high level of accuracy.

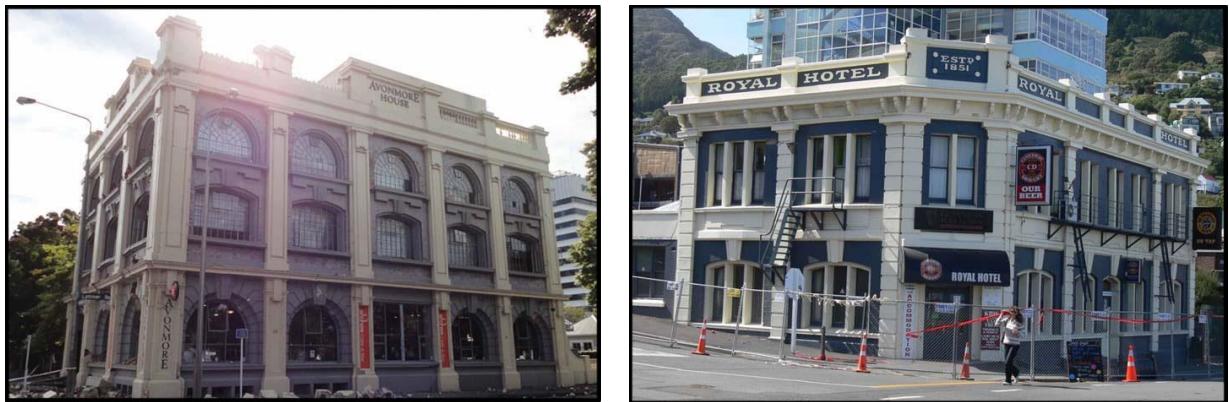
a) Avonmore House

b) The Royal Hotel

Figure 1 - Illustrations of the subject buildings

(photographs taken following the 22 February 2011 earthquake)

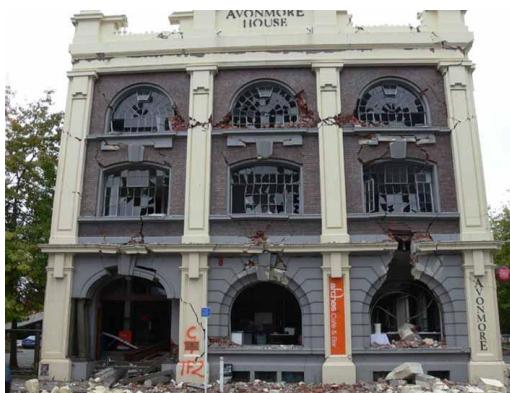
a) South façade of AH after the earthquake. Damage is evident in the spandrels and in the exterior and top piers

In Figure 5 the comparison between the real damage to AH and the results of the simulation carried out with Tremuri is shown. In the simulation the model mainly presented spandrel damage, particularly on the South façade, and this finding is consistent with the damage observed in the building after the earthquake. Furthermore, in this façade (the shorter) it was also possible to identify wide cracks in the piers (mainly in the top storey) that the simulation was able to predict.

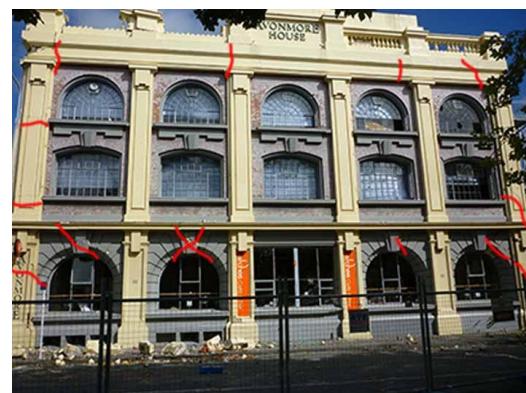
b) East façade of AH after the earthquake. Damage was mainly in the spandrels and external piers

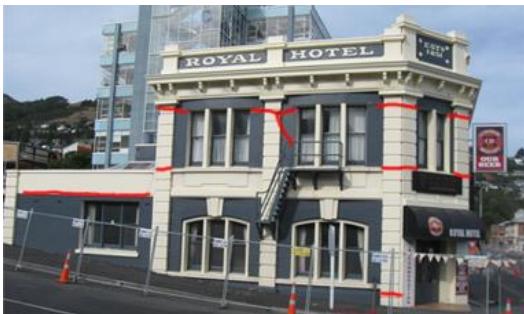
a) Façade of RH on Canterbury road. Cracks are highlighted in red for clarity

RH presented less extensive damage than AH, mainly concentrated in the piers. This observation supports the hypothesis that reinforcement was present in the ring beams. The numerical response, however, seemed to show an overall lower damage if compared with the response of the building during the earthquake. A possible explanation could be that the strong motion was recorded on a different type of soil, and therefore no particular site effect was accounted for. For the meaning of the colours and the symbol of the numerical model screenshots refer to Figure 3.

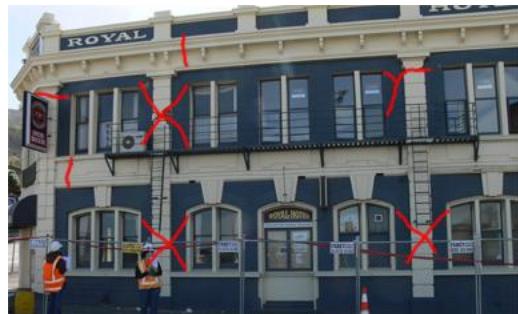
b) Façade of RH on Norwich Quay. Cracks are highlighted in red for clarity
