EFFECT OF SLOW-MOVING LANDSLIDES ON CHURCHES IN THE LIGURIA REGION: A GEOTECHNICAL APPROACH

Keywords: Slow-moving landslide, Historic masonry churches, Damage assessment.

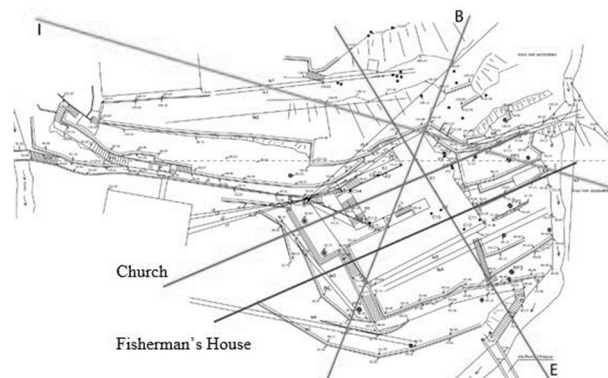
Figure 2: Slope sections analysed.

Once the geotechnical and structural data were collected, several FEM analyses were carried out using PLAXIS 2D software. Figure 2 shows the different sections analyzed and the position of the available investigations for section E. The groundwater level was varied in different positions (according to piezometric monitoring) to evaluate its influence on slope stability, under both free-field conditions and introducing the presence of superstructures. In [12], the different soil types were modelled firstly with the elastic-perfectly plastic Mohr-Coulomb model; then, more accurate FEM analyses were performed by adopting the HSM (Hardening Soil Model), a non-linear isotropic hardening model used to better simulate the real behavior of soils [12]. In this paper, the HSM model was further refined using the Van Genuchten model to simulate the variation of the degree of soil saturation due to groundwater level oscillation as well as rain simulation.

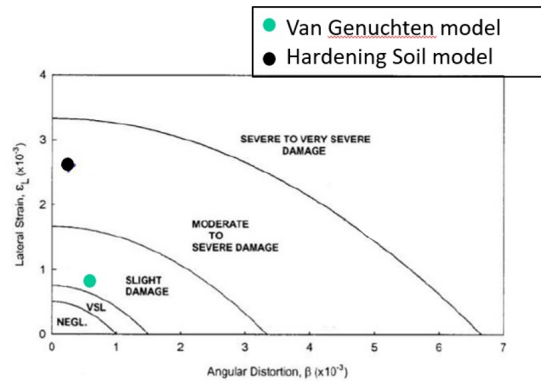
Figure 4: Correlation between angular distortion and lateral strain (obtained from vertical and horizontal displacement, respectively) and damage level, from [15].

The displacement patterns obtained from numerical analyses were also correlated with the damage levels proposed by [13]. It is important to underline that, while the analyses performed using the HSM model indicated a moderate damage level [12], the more refined analyses carried out with the Van Genuchten model classified the damage as slight, in good agreement with the real damage level of the structure (Figure 4). These results demonstrate that a refined geotechnical modeling, possible only in the presence of soil tests, is necessary in order to predict realistically the damage induced on churches by slow-moving landslides.

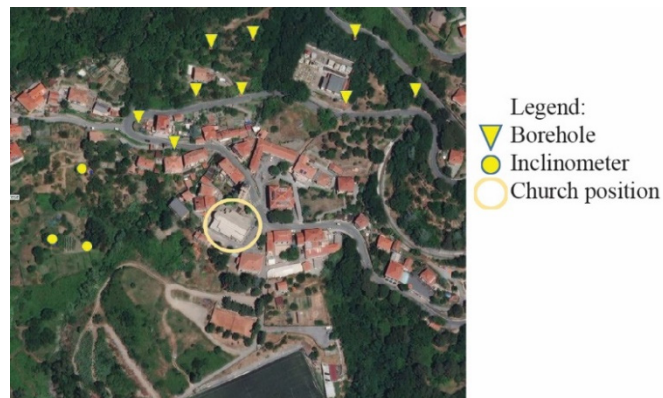
Figure 6: Localization of boreholes and inclinometers in the area of interest.

The church is situated on a slope characterized by a slope angle of 15° (low inclined slope). The area of interest belongs to a large complex active landslide of about 1.09 km^2 . From Figure 6, it can be observed that two inclinometers, installed in the framework of the REMOVER monitoring project of the Liguria Region, are present in the landslide area in the slope adjacent to the one where the church is located (Figure 6). They report a horizontal displacement of 175mm in 9 years, over 15mm/yr. However, no inclinometers can be found on the slope on which the church is situated.

It is important to point out that the area surrounding Sant'Olcese church is not actually well monitored. Only few boreholes, which allowed to define the stratigraphic sequence as well as to model soil stratigraphy, are available in the area uphill of the church. Conversely, no boreholes are present in the downhill area, as shown in Figure 6. Furthermore, no geotechnical tests for the characterization of the soil were performed.

The results of numerical analyses do not appear to be in good agreement with the crack pattern observed in the church. In fact, the heavy damage exhibited by the building as well as the occurrence of parallel cracks in vaults and floors oriented perpendicular to the landslide direction clearly indicates that the church has been subjected to slope movements. The absence of significant soil displacements obtained from numerical analyses can be attributed to the fact that the lack of detailed geotechnical data did not allow for an accurate modeling of the soil. The latter could be achieved by performing new in-situ tests and boreholes, especially in the area downhill of the church, in order to obtain a detailed stratigraphy and fully characterize soil parameters.

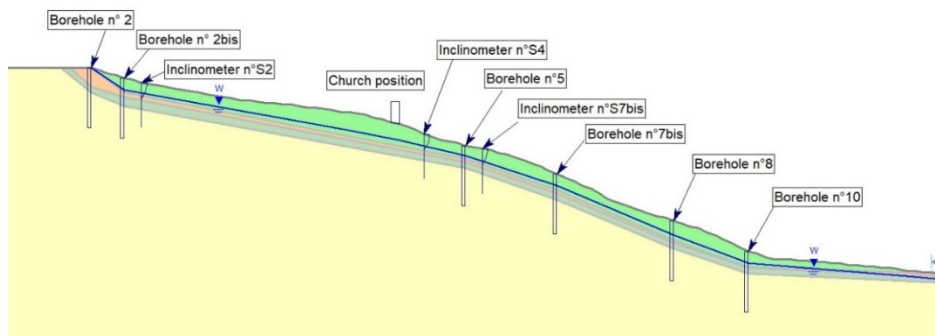
Figure 9: Boreholes and inclinometers localization along the section analysed.

Thanks to the GIS software and the acquisition of DTM data of the area, it was possible to obtain a sufficiently precise topographic survey, in order to trace representative sections along the slope, particularly in the direction of the landslide. Figure 9 shows a section of the slope created in SLIDE along the landslide direction. The position of boreholes and inclinometers as well as of the adopted stratigraphic sequence are also indicated.

Regarding horizontal displacement, a maximum value of about 20 mm is obtained under the church when analyzing the slope section along landslide direction. This displacement value is in good agreement with the horizontal displacement recorded by the inclinometers and reflects the width of the gaps of the floors. These latter can be, indeed, attributed to the significant horizontal movement experienced by the church in the direction of the landslide. As for vertical displacements, they may explain the rotation of the apse towards the interior of the church.

The presence of severe cracks localized in the second bay of the church as well the settlement experienced by the left part of the church with respect to the right one can be attributed to the occurrence of differential settlement in this area. These displacements could have been responsible for the structural instability of the bell tower, which was strengthened in 1988. It is evident that such local phenomena cannot be captured when modeling the behavior of the entire slope.
