## Effect of slow-moving landslides on a vaulted masonry building: The case of San Carlo Borromeo church in Cassingheno (Genova)

**ABSTRACT:** This paper presents the structural analysis of San Carlo Borromeo church, a masonry building located in Cassingheno (Genoa, Italy) in an area affected by a slow-moving landslide. A deep knowledge of the building in terms of geometry, structural configuration, history and construction phases was acquired by means of on-site surveys and archival research. The crack patterns were surveyed in detail and the deformations were studied through a point cloud obtained from a LIDAR survey. The comparison between the landslide direction and the damage observed showed discrepancies and suggested the presence of foundation settlements due to other phenomena. To identify the actual causes of damage, a finite element model (FEM) of the building in its hypothetical undeformed configuration was created. The geometry of such configuration was reconstructed starting from the point cloud obtained from the LIDAR survey and removing geometrical defects such as leaning of walls, deformation of vaults and inclination of tie-rods. To simulate the effects produced b

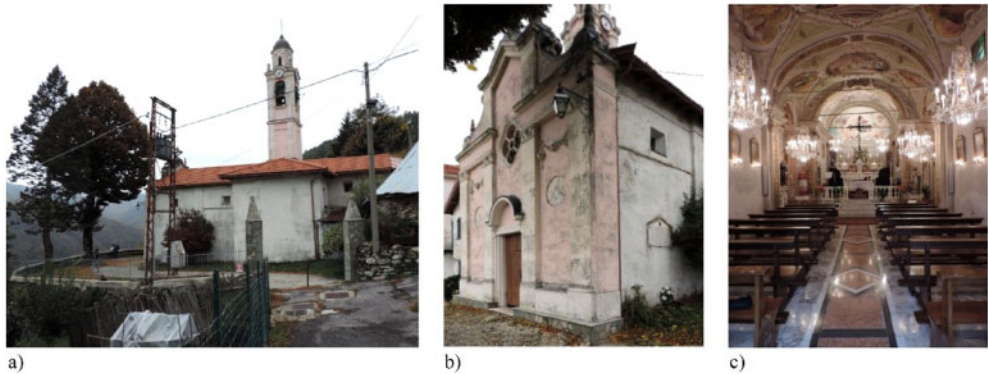
San Carlo Borromeo church (Figure 2) has a single nave, a presbytery, a semicircular apse, two lateral chapels and a belltower. Including the apse, the church is about 20 m long and 6 m wide. The nave and the presbytery are covered with barrel vaults, while the apse has a hemispherical dome. The entire building (both walls and vaults) is made of stone masonry and is covered by a recently built wooden roof. A clergy house and a sacristy, respectively made of stone and brick masonry, are also present on the north-western side of the church.

Figure 2. (a and b) Exterior. (c) Interior.

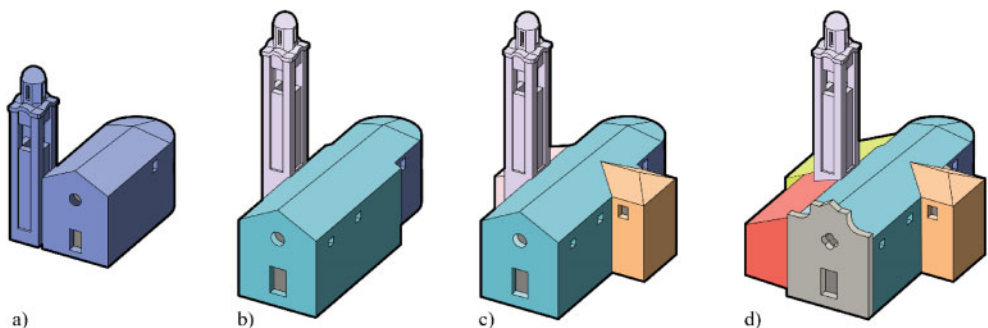
Figure 3. a) Original building - late Middle Ages. b) Church – before 1595. c) Right chapel – before 1879 d) Current configuration – early 19th sec.

parts of the original building, while the current nave, whose walls are not perfectly aligned with those of the apse, was constructed later with a size larger than the original one (before 1595). The current belfry was added at the same time of the enlargement of the nave or just after, leading to the configuration shown in Figure 3(b). Subsequently, before 1879, a sacristy and a chapel were built on the left and right sides of the church, respectively (Figure 3(c)). Between the end of the eighteenth century and the first half of the nineteenth century, San Carlo Borromeo church underwent further transformations, including the construction of the clergy house (colored in red in Figure 3(d)) and the reconstruction of the original sacristy, which brought the building to its present form (Figure 3(d)). An intervention to straighten the belltower was also carried out after the Second World War, hiding most of the rotation experienced by this structure over the centuries.
