Model Scale Investigation of Blade Root Cavitation Erosion on a Set of Marine Propellers

Afaq Ahmed Abbasi ¹, Giovanni Franzosi ¹, Daniele Bartetta ², Marina Delucchi ³,
Michele Viviani ¹ and Giorgio Tani ¹

ABSTRACT

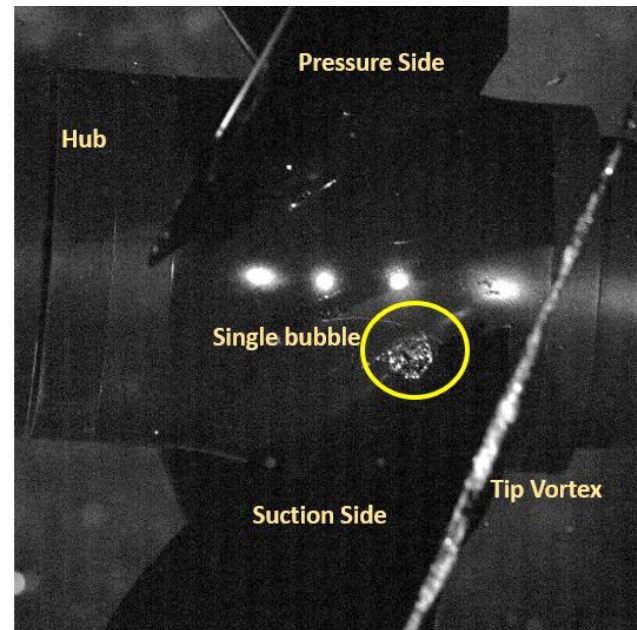
Cavitation observed on P1 propeller has been thoroughly described in (Abbasi et al 2022). This is moderate root bubble cavitation, consisting of one or few separate bubbles occurring at blade root around 90°, for most of the blade passages. The overall global cavitation on suction side for P1 is shown in Figure 2. Interestingly, bubbles were not observed for all the blade passages, i.e., in some cases there were passages without any root bubble collapse. The cause of this cavitation intermittency can be reasonably attributed to scale effects mostly related to water quality, which are usually more critical for cavitating conditions close to inception.

Figure 2. Global cavitation on suction side root for P1 Propeller (flow is from left to right)

The collapse occurs in slightly different forms depending on the size and location of the bubble. Larger cavities destabilize from the centre, creating a number of minor cavities, some of them usually collapse with a rapid volume contraction towards the point where paint removal is observed, i.e., a small area at the trailing edge of the blade fillet, including also part of the hub surface.

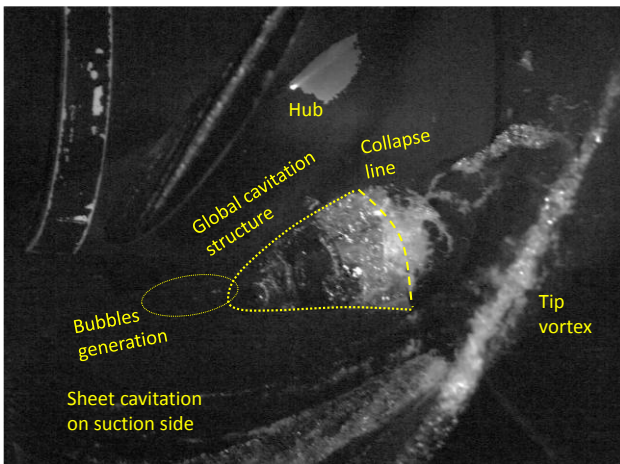
Figure 4. Global cavitation on suction side root for P2 Propeller (flow is from left to right)

For P2 propeller bubble cavitation has been observed on the blade root. Suction side root bubbles are continuously generated between the leading edge and mid-chord. During their motion downstream coalescence occur in between them, and a complex structure extending from the hub surface to about 0.5 R, with a shape similar to that of a wedge. The sub-structures detectable on the irregular surface of this bubble assembly are convected downstream until they reach the cloudy trailing edge of this cavity. Here bubbles are continuously destroyed by collapse taking the appearance of a collapse line. This complex collapse process generates minor cloudy cavities and twisting vortexes, some of which collapse on the hub while the others are convected downstream.

It is worth mentioning that severe root cavitation was observed for propeller P2 also on the pressure side. This explains the large damage of the paint visible on the pressure side, e.g. in Figure 4. In this work, most of the attention is focused on the analysis of the erosion associated to suction side root cavitation, therefore this phenomenon will not be further analysed.

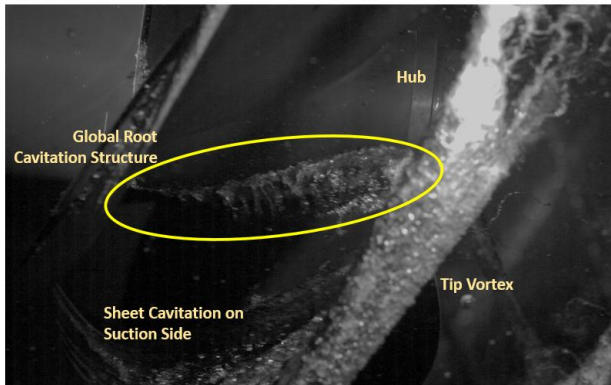
P3 propeller exhibited heavy cavitation at the blade root. The aspect of suction side root cavitation for this propeller is rather similar to that described for P2: bubbles are continuously generated at leading edge; they grow while moving downstream and they merge forming a wedge like structure whose thickness increases downstream until the collapsing region is reached at blade trailing edge.

Figure 6. Global cavitation on suction side root for P3 Propeller (flow is from left to right)

Compared to the one observed for propeller P2, root cavitation of propeller P3 is characterised by a higher bubble production rate, with the bubble assembly extending from the leading edge for the whole length of the chord. However, in this case the cavitation evolution during blade rotation is completely different, as it can be seen in Figure 7.

Actually, after reaching the maximum extent around 90° , the global cavitation structure contracts violently in all the directions toward a region located approximately at $0.4R$, and $0.4C$, where violent collapse events are observed. During this process, secondary collapses are observed along the outer edge of the wedge like cavity, associated

After the collapse of the main cavity, large rebound phenomena are observed, usually forming a rather large cloud cavitation which moves downstream and further collapses almost in correspondence to the trailing edge. The motion of this cloud is characterised by significant spin around a direction almost parallel to the trailing edge, apparently caused by the collapse itself.
