SEISMIC BEHAVIOUR OF ORDINARY MASONRY BUILDINGS DURING THE 2016 CENTRAL ITALY EARTHQUAKES

Sorrentino L., Cattari S., da Porto F., Magenes G., Penna A.

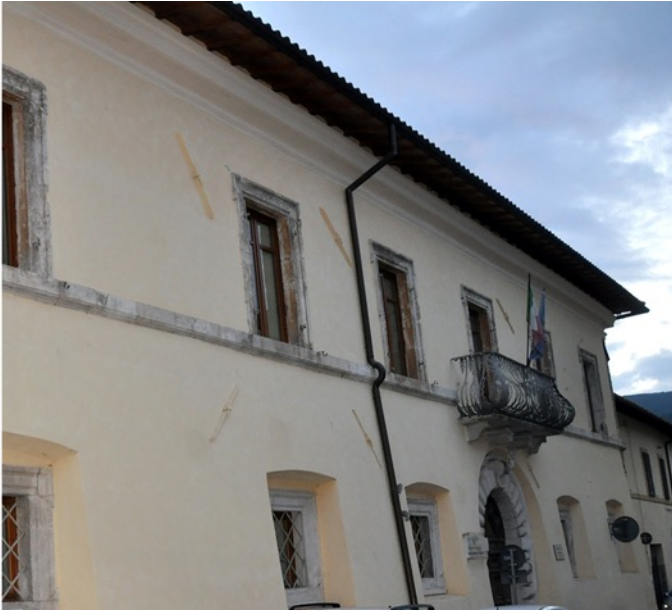
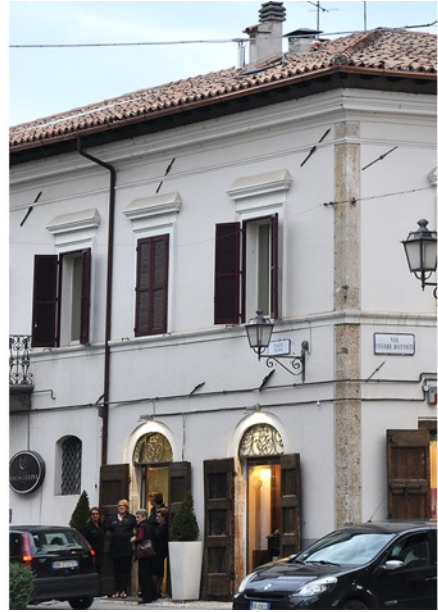
The maximum height of constructions was limited to two storeys and 8.5 m at the eaves. These limitations applied also to damaged buildings to be repaired, so only undamaged or very lightly damaged third floors were preserved. As a matter of fact Norcia presents lower rise buildings (Fig. 3a-b) compared to other Italian historical centres and to the other municipalities most damaged by the 2016-2107 seismic sequence (Table 2). The girders of roofs and floors had to rest on the whole cross section of the walls, to which they had to be connected by metal anchors (Fig. 3a-b). Tie rods were compulsory when existing vaults were preserved at ground storeys. At the upper storey vaults were always forbidden and in the case of substantial repair works or new constructions they were permitted only in the basement. The minimum thickness of vaults was set to 250 mm or 1/18 of the radius, whichever the largest. Solid masonry had to connect wall and vault up to 1/3 of the rise. The recommendations in the building code were clearly inspired by the survey led by father Secchi, to which participated also architect Luigi Poletti, who performed several structural repair works after major earthquakes (Sorrentino et al. 2008).

Fig. 3. Norcia. Two-storey buildings, tapered wall thickness, systematic use of tie rods. a) via Cavour, b) piazza Giuseppe Verdi.

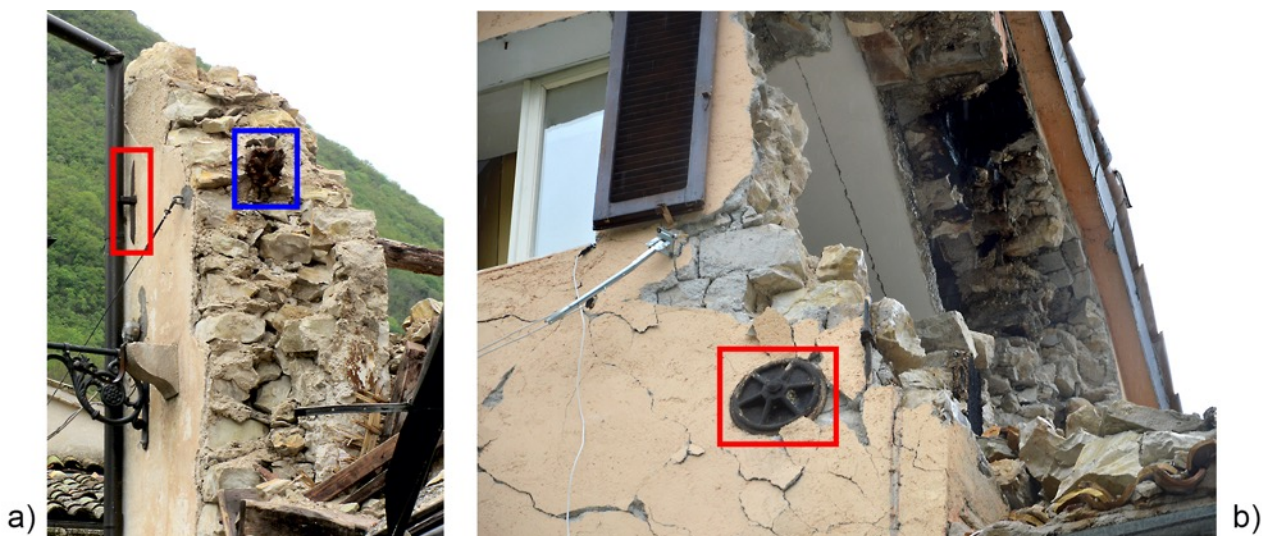
Fig. 4. Timber tie rods (blue frame) and steel wall anchors (red frame) in Castelsantangelo s/N: a) Via Parco della Rimmembranza, b) via delle Mura Castellane.

Timber and/or steel tie rods are present also in Castelsangelo s/N (Fig. 4), although in a less systematic way than in Norcia. In Castelsantangelo buildings are mostly characterised by a rubble stone masonry with two leaves, not always well connected. The municipalities of Amatrice and Accumoli had been surveyed before the earthquake by Fumagalli et al. (2017). The historical centre of Amatrice had buildings clustered in structural aggregates, mostly two-three storeys high, with an average storey height in the 2.5-3.5 m range. Walls at ground floor had a mean thickness of about 0.70 m.

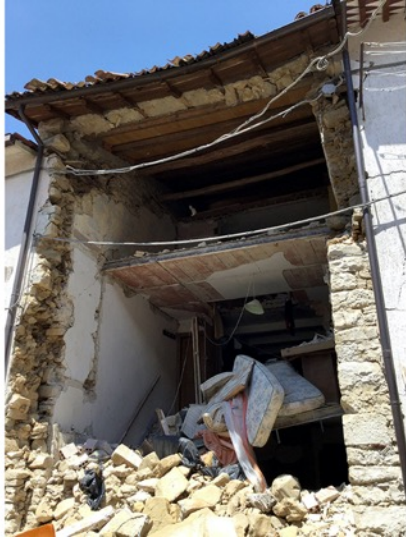
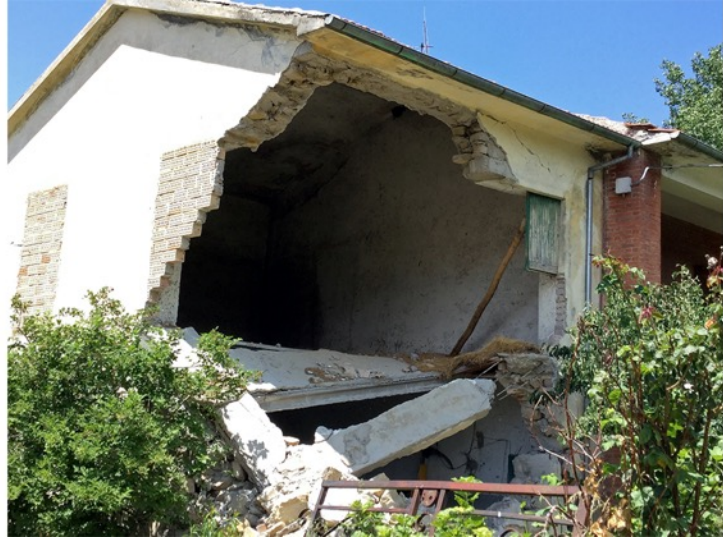
Fig. 6. a) I-beam and hollow clay block floor, Amatrice, Retrosi; b) Precast reinforced concrete beams and hollow clay block floor, Amatrice, Moletano.

The earthquake has shown how masonry had two or three unconnected layers across the thickness, units were not dressed and mortar was usually made of mud (Fig. 5). Intermediate horizontal structures were mostly timber structures and, to a lesser extent, jack-arch or I-beam and hollow clay block floors (Fig. 6). Structural vaults were present at ground floor in about one third of the building stock. Ties and/or ring beams were present in just about one fifth of the portfolio, much less than in Norcia (Fig. 3), either as iron wall anchors of timber elements (Fig. 7) or as modern steel rods (Fig. 8). The roof had a timber structure in most cases, but in about one tenth of cases it had been replaced by a reinforced concrete structure. In such instances internal horizontal structures had been usually replaced, as well.

If disintegration due to poor masonry quality occurs any modelling of building response becomes unreliable (Sorrentino et al. 2017). As shown in Fig. 13, when masonry has such a low strength even the systematic use of steel ties is ineffective. When combined with a reasonable quality masonry, steel ties certainly contributed to preventing collapse (Fig. 3, Fig. 8). Nevertheless, besides the low masonry quality, the limited presence of connections in many buildings, the reduced strength of lateral walls compared to large-units wall intersections (Fig. 14), as well as the presence of intermediate floors having scarce diaphragm effect, poor details at the bearings, and no connections to the walls parallel to beams, should be recalled (Fig. 6).

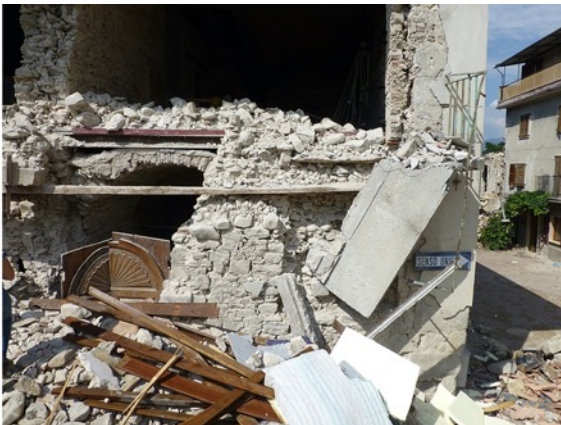
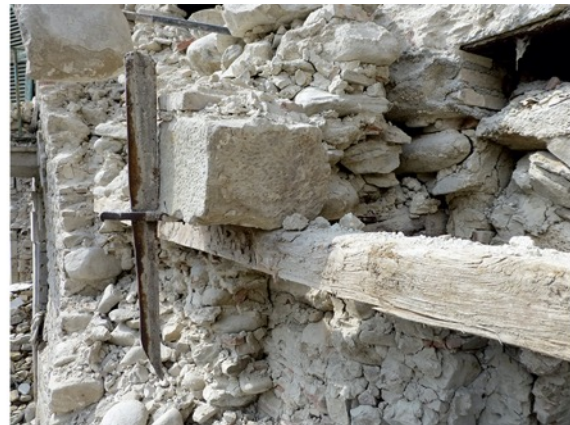
Fig. 7. Iron wall anchor of timber tie, Amatrice, via Roma. a) General view; b) Close up of a wall anchor.

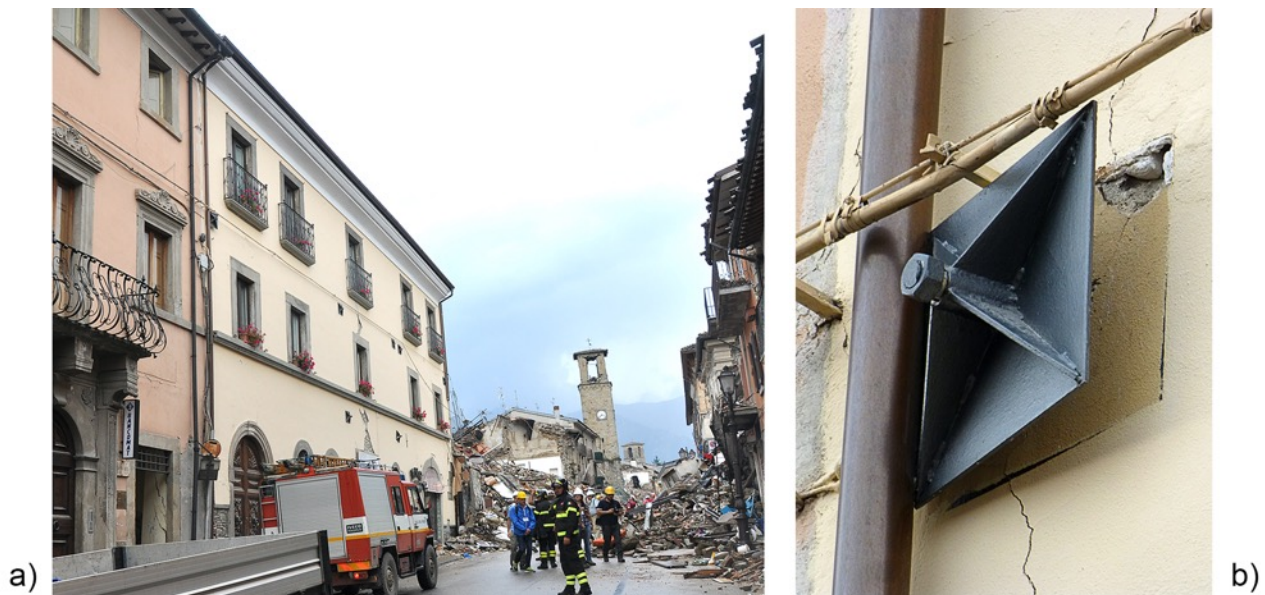
Fig. 8. Steel tie rods in the lightly coloured building, Amatrice, corso Umberto I. a) General view; b) Close up of a wall anchor.
