Article

Historical Geomorphological Research of a Ligurian Coastal Floodplain (Italy) and Its Value for Management of Flood Risk and Environmental Sustainability

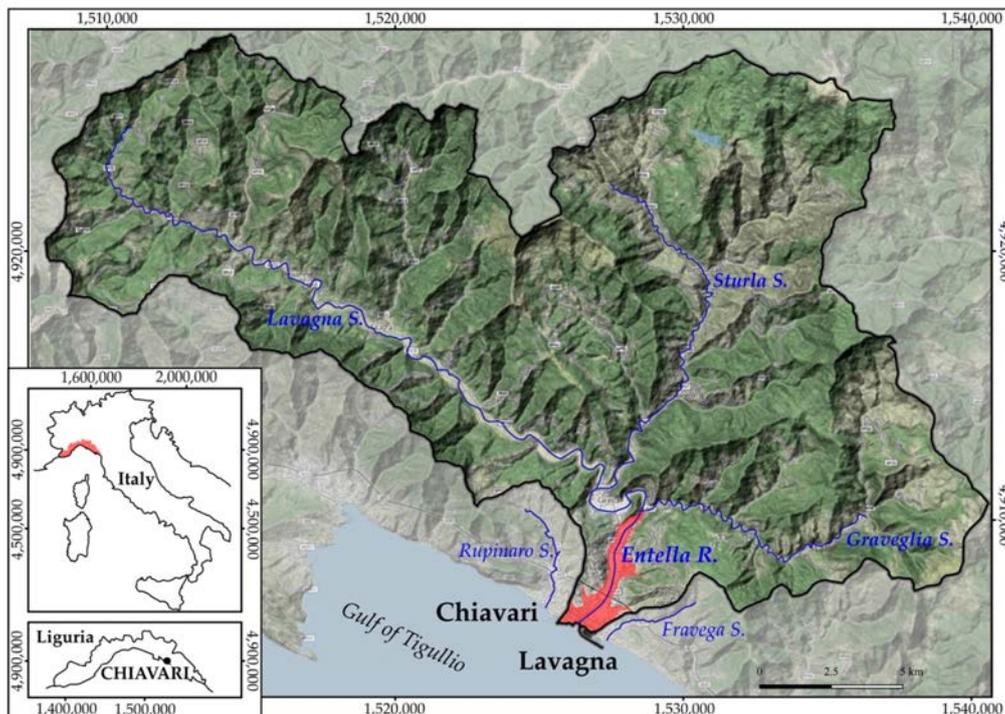
Figure 1. Relief map of the Entella River catchment. Lavagna, Sturla and Graveglia Streams, the three main tributaries, area indicated. Red area delimits the examined alluvial plain of the Entella River.

The study area is the floodplain reach of the Entella River that extends for 7 km² in the central sector of the Gulf of Tigullio (Figure 1). Three watercourses cross through the floodplain: the largest is Entella, which flows in the central sector, with the Rupinaro and Fravega streams at the western and eastern edges. The basin of Entella covers 375 km² and comprises three tributaries: the Lavagna catchment (160 km²), the Sturla catchment (130 km²) and the Graveglia catchment (63 km²).

Figure 1 shows that the Entella starts at the confluence of the Lavagna and Graveglia streams; the Sturla joins 4 km below this confluence. The coastal floodplain results from combined and cyclical

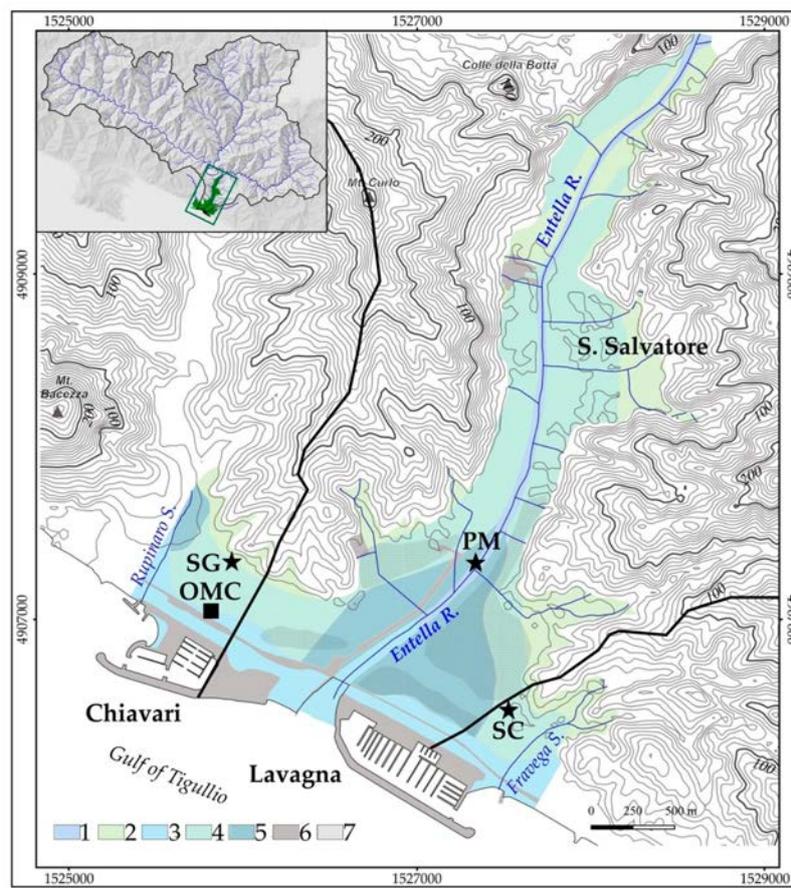
Figure 2. Engineering geological map of the Entella floodplain [34]. 1. Gravel, with subordinate sand and little or no fines; 2. Gravel and sands, with significant fines; 3. Sand, with subordinate gravel and little or no fines; 4. silty sand, gravelly silt and sandy silt; 5. clayey silt and inorganic silty clay, with a granular fraction (sand or gravel); 6. Man-made deposits, include coarse soil frequently mixed with heterogeneous material (pitch, bricks, etc.); 7. marshes, swamps. Black stars show reference points: SG, “San Giovanni Battista” Church; PM, “Ponte della Maddalena” bridge; SC, “Nostra Signora del Carmine” Church. Black square shows the Weather Station OMC, “Osservatorio Meteorologico di Chiavari”.

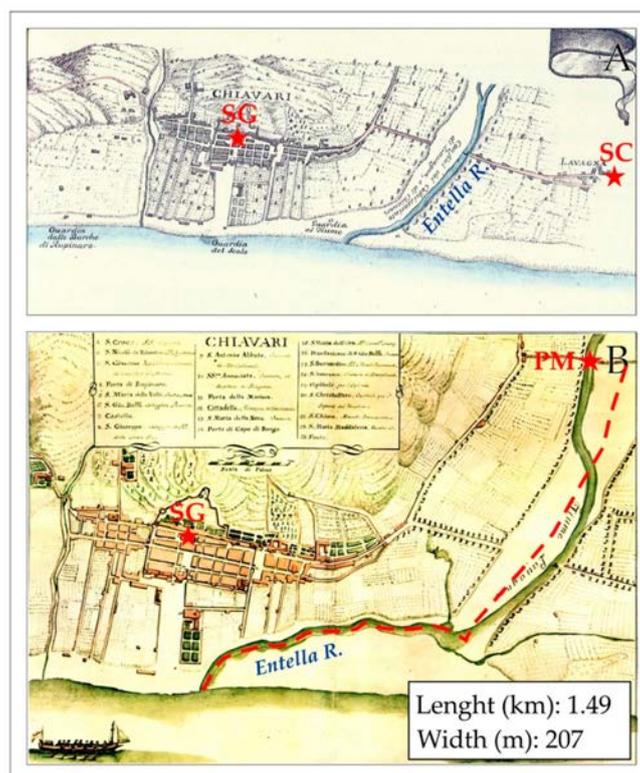
Figure 3. The Entella River floodplain in the 18th century: (A) “Pianta delle Due Riviere della Serenissima Repubblica di Genova divise ne’ i Commissariati di Sanità”, 1758; (B) “Il Dominio della Serenissima Repubblica di Genova in terraferma”, 1773. Red stars show reference points: SG, “San Giovanni Battista” Church; PM, “Ponte della Maddalena” bridge; SC, “Nostra Signora del Carmine” Church. (See also Figure 2). Red dotted line shows the axis of the channel. Values of the channel length and width are measured at the PM reference point.

Visual inspection of maps by Vinzoni dated 1758 and 1773 reveals the original geomorphological landscape of the Entella floodplain (Figure 3). The Entella was free to wander in its floodplain, characterized by a large channel and a mouth displaced westward, compared to the present river configuration. At the bridge “Ponte della Maddalena”, the riverbed reached 200 m across (Table 4).

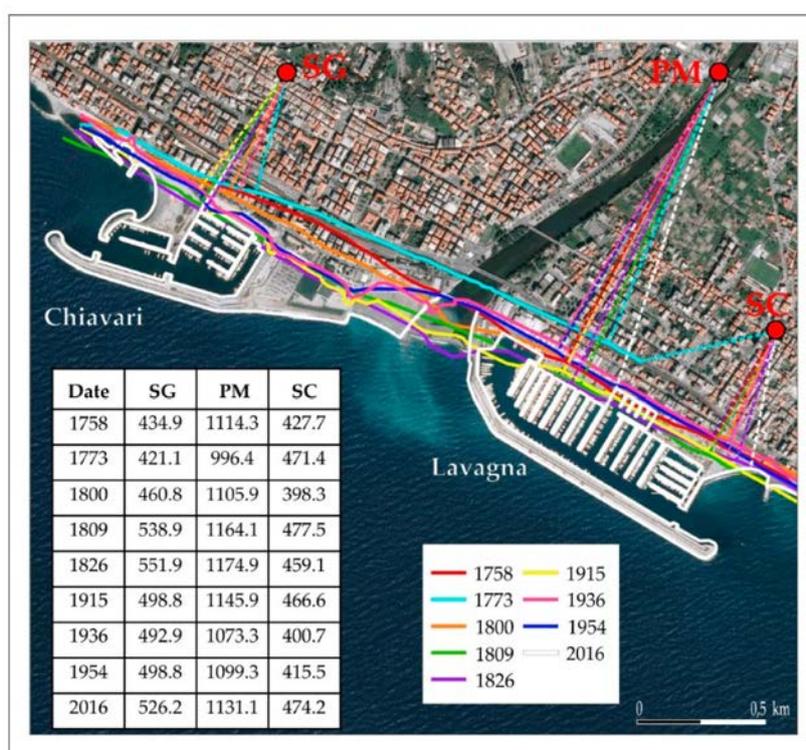
Figure 4. Evolution map of the shoreline from 1758 to 2016. Colored lines represent the different stages of coastal modification. Dotted colored lines show the distance measured from the reference point: SG, “San Giovanni Battista” church; PM, “Ponte della Maddalena” bridge; SC, “Nostra Signora del Carmine” church. Measured values (m) are reported in the table.

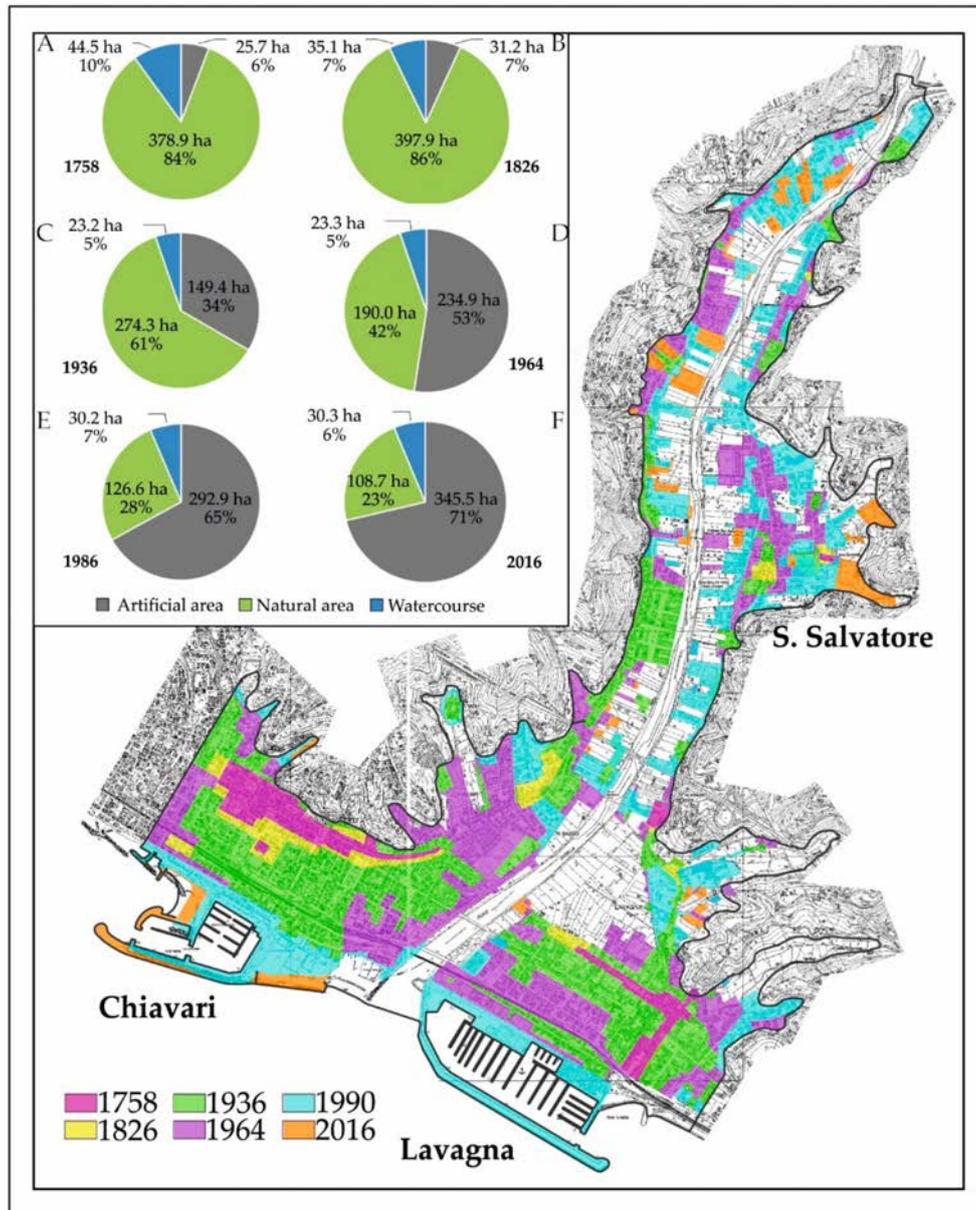
Figure 5. Urban evolution map of Chiavari and Lavagna from 1758 to 2016. Pie charts (A–F) show the relationship between artificial areas (continuous and discontinuous urban fabric, port areas and artificial, non-agricultural vegetated areas), natural areas (forested areas, olive groves and cultivated areas) and watercourse in the same period.

The medieval settlement of Chiavari developed westward and incorporated the village of Rupinaro; in the 18th century (Figure 5), the municipal area stretched between the foothills and

The interventions along the river favoured the sedimentation of alluvial deposits and shoreline advance, due to the continuous supply of materials to the plain and the beaches. Consequently, there was an increase in length of the distance between the coastline and the reference points, up to the maximum value in 1826 (Table 4). The urban development of Chiavari and Lavagna during the 19th century was moderate: only a limited and discontinuous expansion took place toward SW in the coastal strip between the mouths of the Entella and the Rupinaro, previously almost exclusively occupied by market gardens or marshland, whereas a small suburban district grew along the western riverside next to the "Ponte della Maddalena" bridge (Figure 5). Between 1868 and 1870,

The most important landscape modifications took place between the 1950s and the 1980s (Figure 5). Post-war population increase and economic growth caused rapid and massive urban sprawl in both Chiavari and Lavagna. By 1964, artificial spaces accounted for 53% of the floodplain (Table 6, Figure 5D), with most being discontinuous built-up areas (26%) (Table 7, Figure 6D). The residential area of Chiavari extended in the western sector of the floodplain and inwards along the western bank of the Entella; on the other riverside, the municipal areas of Lavagna extended as far as the river (Figure 5). Between the 1960s and the 1970s, the coastal sector of the floodplain was heavily urbanized with residential and tourist developments from the shoreline up to the foothills, with agricultural areas interspersed within the discontinuous urban fabric that characterized the inland suburban districts of Chiavari and Lavagna and the village of San Salvatore (Figure 5). The channelization of the lower stretch of the Entella was completed with the construction of the new bridge “Ponte della Pace” along the Aurelia Way, upstream the railway and downstream the existing bridge “Ponte della Libertà”. Since the 1950s–1960s, the flow section of the river in its lower stretch has stabilized: no substantial changes in channel width have been observed at the bridge “Ponte della Maddalena” (Table 3).

The rapid increase of the built-up area between the 1950s and 1980s caused the almost total saturation of the coastal sector of the floodplain (Figure 5). By 1986, artificial surfaces occupied more than 67% of the floodplain (Table 6, Figure 5E): continuous built-up areas are predominant (40%), whereas olives groves and agricultural land are strongly reduced (24%) and survive in the floodplain inland area and along the foothill, interspersed with a discontinuous urban fabric (21%) (Table 7, Figure 6E). The woodland at the mouth of the Entella River was also much reduced; at present a small pinewood (0.4 ha) survives in the municipal parks along the two riverbanks between the modern bridges.

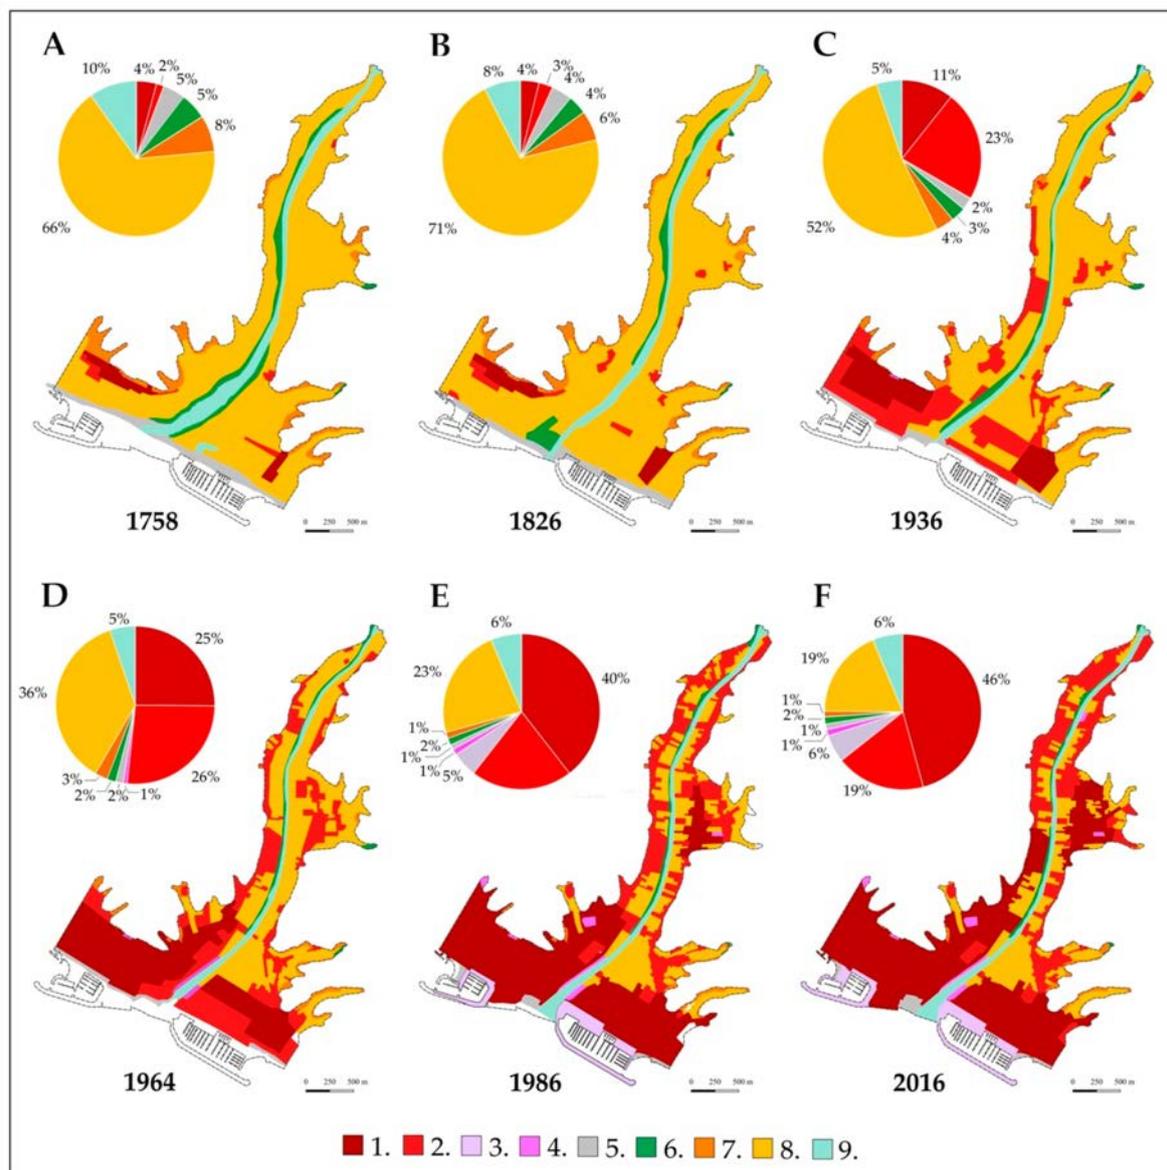
Figure 6. Land use changes from 1758 to 2016. Pie charts (A–F) show the relationship between different types of land use and land-cover categories provided by the CORINE project. Land use categories: 1, continuous urban fabric; 2, discontinuous urban fabric; 3, port area; 4, artificial, non-agricultural vegetated area; 5, shore; 6, forested area; 7, olive groves; 8, cultivated area; 9, watercourse.

During the 18th century, vegetated areas with horticulture, agriculture and woodland were the dominant land type, the area of which accounted for 84% of the total land, and small artificial surfaces occupied only 6% of the flat area (Table 6, Figure 5A). The floodplain was largely occupied by agricultural land, with market gardens, olive groves, vineyards and fruit orchards, both in the coastal sectors and in the inland areas (74%); there was some woodland at the mouth of the river and trees grew on the banks (5%), while shores represented the 5% of the natural spaces (Table 7, Figure 6A).

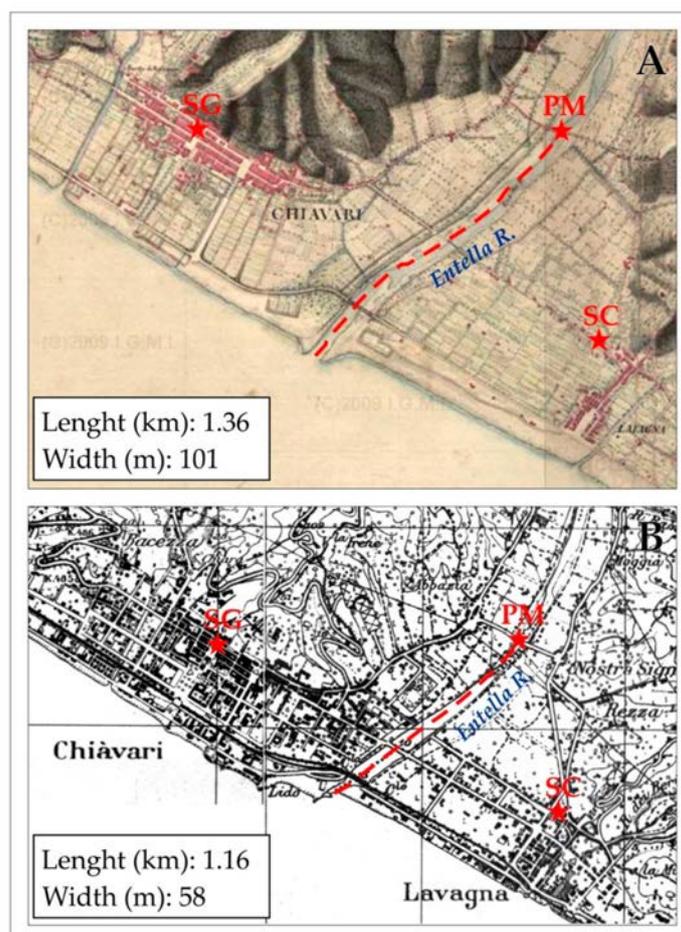
Figure 7. The Entella floodplain in the 19th and 20th centuries: (A) “Gran Carta degli Stati Sardi in Terraferma, Riviera di Levante”, Istituto Geografico Militare Italiano, 1816–1826; (B) “Carta Topografica d’Italia—serie 25, Foglio 94, Tavolette I-NO “Chiavari” e I-NE “Sestri Levante”, Istituto Geografico Militare Italiano, 1936. Red stars show reference points: SG, “San Giovanni Battista” Church; PM, “Ponte della Maddalena” bridge; SC, “Nostra Signora del Carmine” Church. (See also Figure 2). Red dotted lines show the axis of the channel. Values of the length and width channel are measured at the PM reference point.

In the early 19th century (Figure 7A), the artificial canals to the east of Chiavari were still in use. The main morphological effect of human impact was the eastward movement of the river mouth and the marked narrowing of the channel, to a minimum of 89 m in 1800 (Table 4). New cultivated areas replaced the old marshland next to the mouth, increasing the area of the plain covered with vegetation (84%); the moderate expansion of Chiavari slightly increased artificial surfaces, whose area accounted for less than 10% (Table 6, Figure 5B). Market gardens, olive groves and orchards were the dominant land uses (77%) (Table 7, Figure 6B). The wood at the mouth of the Entella, in a place called *Il Prato*, belonged to the noble Rivarola family who established a plantation of mulberry trees along the river [58]. The wood was composed of willows, alders and lime trees, all species that grow in wetlands and along rivers [59]. Visual evidence of this wood is provided by a pen drawing by William Strangways ("From above Chiavari on the road to Genoa", DocSAI Center, Topographical Collection, Genoa), which also shows the flat area, with a characteristic chessboard pattern of land plots.

During the 20th century (Figure 7B), there was very rapid urbanization of the coastal floodplain: new buildings, roads, bridges, commercial and production sites replaced many cultivated and vegetated areas. In the early 20th century, vegetated regions were reduced by 10% and the built-up areas increased fivefold over the century (Table 6; Figure 5C). The discontinuous urban fabric characterized the coastal sectors (23%), surrounding the continuous residential districts (11%) of the historical centers of Chiavari and Lavagna (Table 7; Figure 6C). The municipal development of the two seaside towns was rapid, with a marked expansion in the coastal sector of the plain and towards SW and the Entella riversides (Figure 4). In Chiavari entirely new exclusive neighbourhoods were built between the historical center and the railway, and secondarily in Lavagna, between the historical center and the Entella. Many were built for wealthy people who returned from North and South America, where they had migrated to seek fortunes at the end of the previous century. Cultivated land account for 52% of the total area and dominate the middle and inland sectors of the plain: olive groves survived at the foot of the hills, and woodland along the riversides (Table 6, Figure 5C). Around 1910, channelization interventions with concrete levees were carried out along the lower stretch of the Entella River [53,60] and next to its mouth due to the construction of the new bridge “Ponte della Libertà” about 250 m

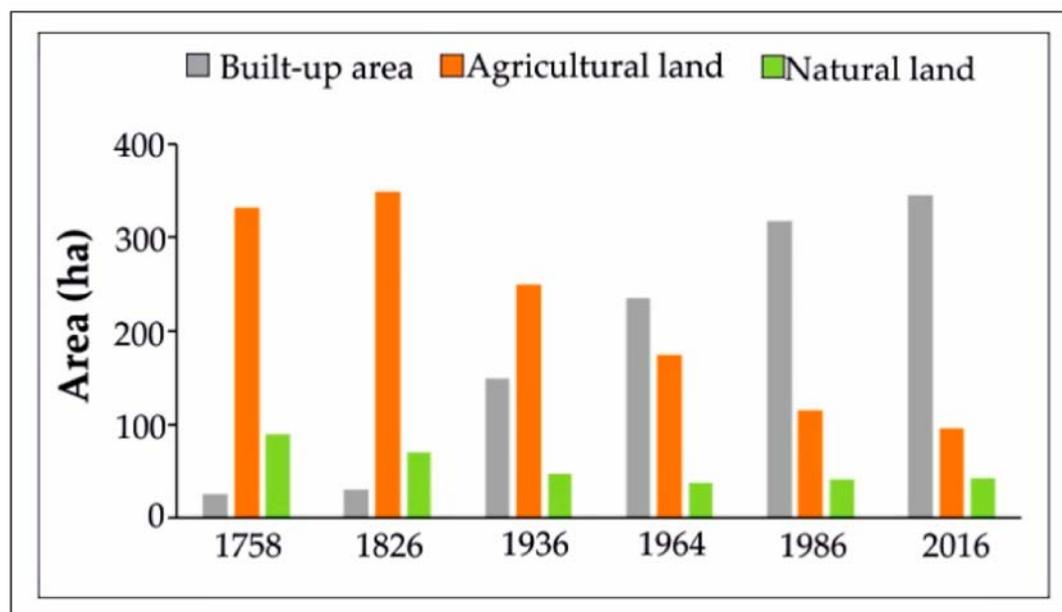
**Figure 8.** Land use modification over the last two centuries: built-up area includes urban fabric, port areas and artificial, non-agricultural vegetated areas; agricultural land includes complex cultivated land and olive groves; natural land includes forested areas, shores and watercourse.

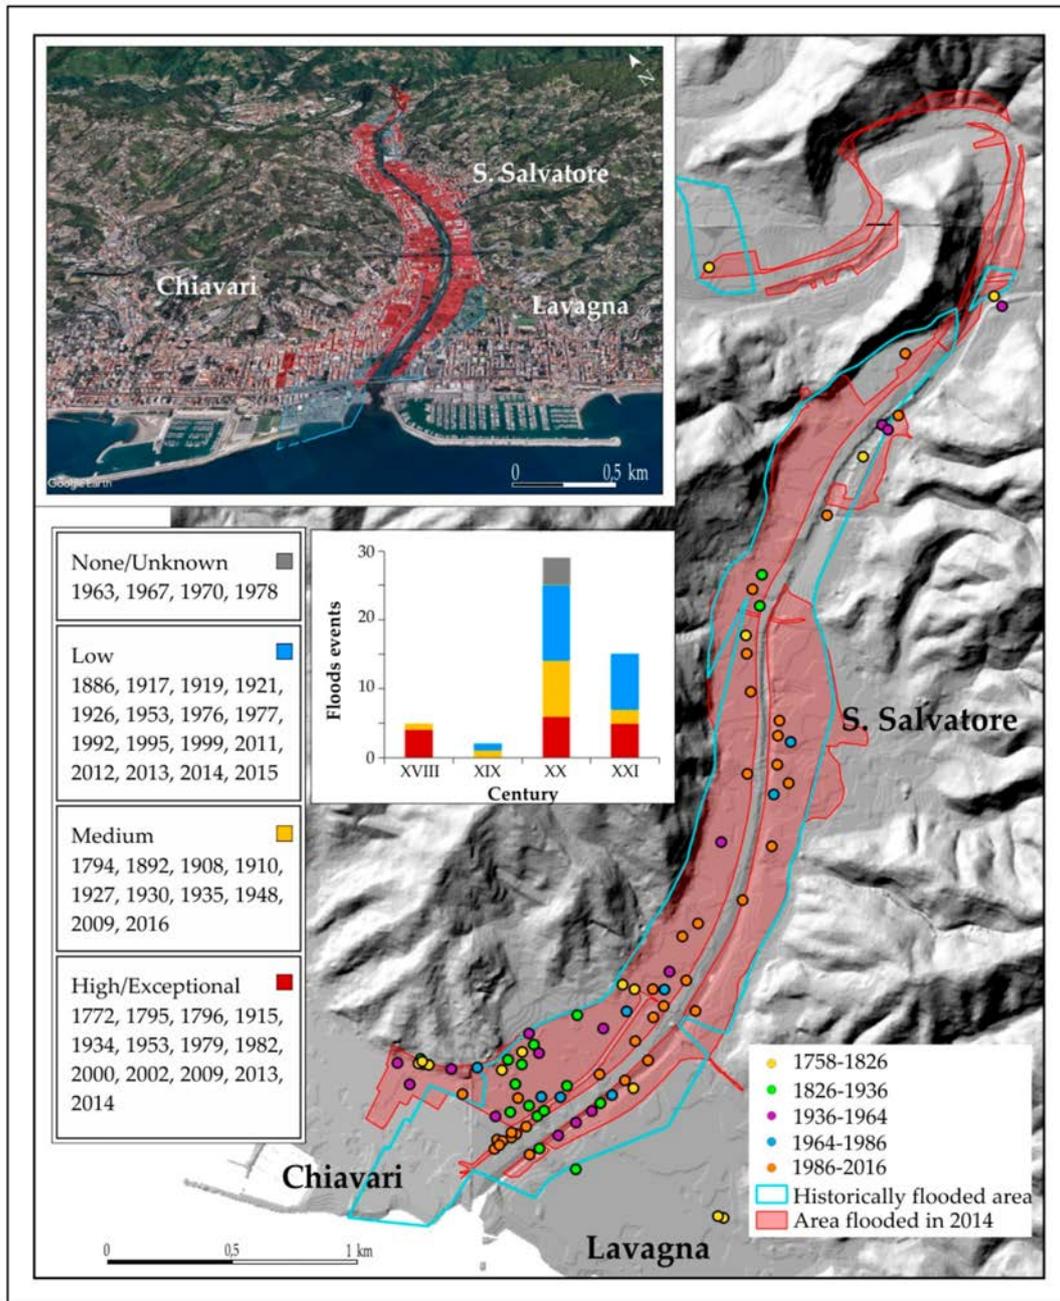
Figure 9. The main map shows the distribution of flood events (colored dots) that occurred in the Entella floodplain from 1758 to 2016. Events are classified into the five time breaks adopted in the historical analysis. Blue areas show the urban region historically flooded and red areas show the urban region that were inundated during the flood events of the year 2014. The table lists the years in which flood events occurred, classifying them according to the level of damage (none or unknown, low, medium and high or exceptional): years with exceptional floods are in bold, stars indicate years with events that caused fatalities. The graph shows the temporal distribution of the flood events.

From 1758 to 2016, heavy rainfalls and intense rainstorms caused both regular and flash floods: flooded areas are historically the flat regions neighbouring the river channel along both riverbanks, where San Salvatore village and the present inland suburban districts of Chiavari stand, and large

sectors of the coastal plain at the mouth, including several present residential districts of Chiavari and Lavagna (Figure 9).

some of its tributaries (Lavagna stream) flooding large sectors of the floodplain and the Lavagna valley floor with significant damage to buildings, roads and industrial sites; (iii) 10 October 2013, when large portion of the plain and the Lavagna and Sturla valley floors were inundated and the flood wave caused two fatalities due to the collapse of a bridge in the inland of Chiavari; and (iv) 10–11 November 2014, when the town of Chiavari was largely occupied by waters due to the synchronous flash flood events in the Entella river and the Rupinaro stream, at the western boundary of the plain, caused by very short but intense rainfall events, with extensive damage to shops, basements, garages, roads and buildings in the urban area and to riverbanks, leisure and tourist facilities, industrial and commercial sites along the riversides (Figure 9).

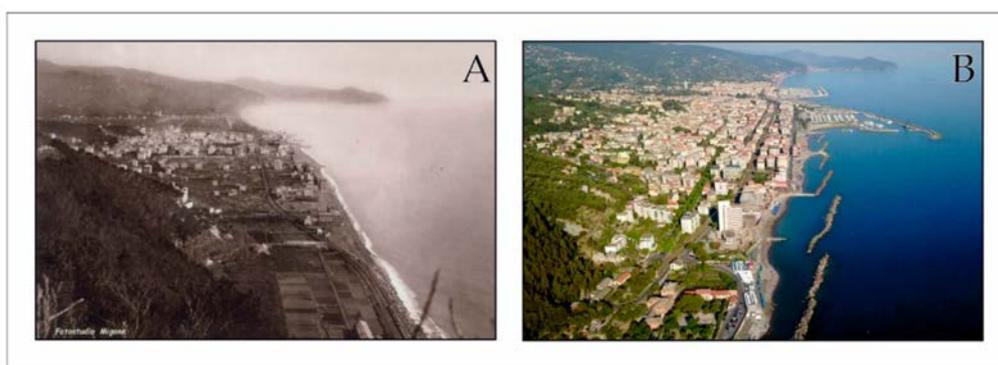
Figure 10. The Entella floodplain and its shoreline and land use modification over the last two centuries: (A) view of Chiavari and the western sector of the floodplain with market gardens, olive groves and vineyards in 1890 (“E. Migone”, photographer archive Chiavari); (B) recent view of Chiavari and its western urban districts and modified shoreline (Photo P. Giacomelli).

- The increase in built-up areas over the entire period 1758–2016, particularly in the late 19th century and after the Second World War, between the 1950s and the 1980s (Figure 5). Transformation from natural to artificial landscape is linked to the urban growth in the coastal and, later, in the inland sectors of the floodplain, with the gradual construction of residential urban and suburban districts and the consequent development of transportation and road networks, industrial sites, port areas and leisure, tourist and service facilities (Figure 10).

- The gradual loss of agricultural land since the 19th century. Human activity is the major factor in this land use change: in the 18th and the early 19th century, cultivations occupied large portions of the plain, and agricultural land was even increased at the end of 18th century as result of human intervention along the channel to reclaim marshy areas at the mouth. Since the late 19th century, the urban sprawl of Chiavari, Lavagna and the village of San Salvatore converted agricultural land into residential and technical areas (Figure 10).

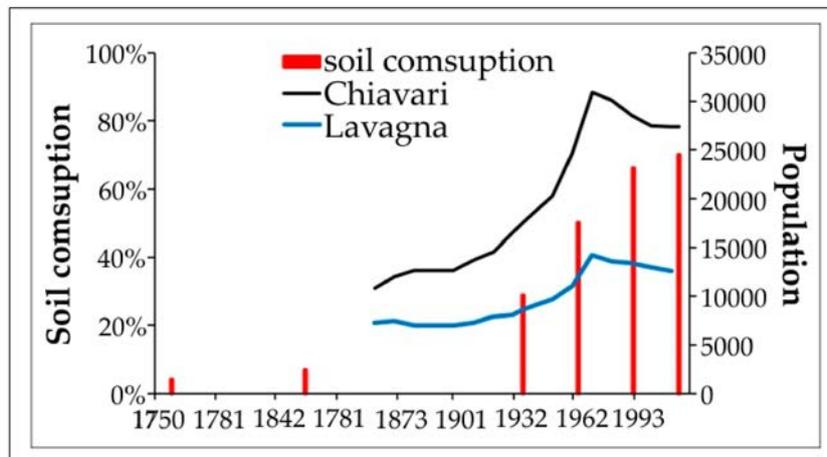
Figure 11. Soil consumption (%) correlated to the population increase (number of inhabitants) in Chiavari and Lavagna over the last 150 years (1861–2014). Red bars represent soil consumption, black and blue lines are the number of inhabitants registered in Chiavari and Lavagna, respectively, by population census from 1861 to 2014.

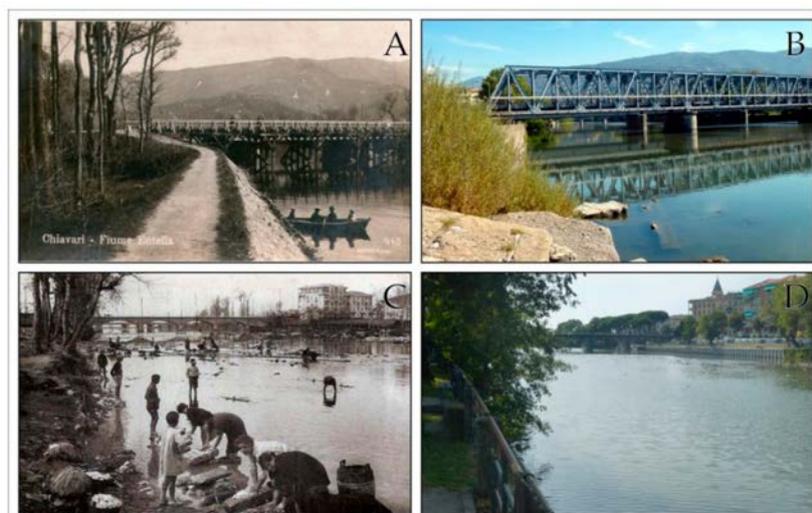
Figure 12. View of the Entella banks over the last two centuries: (A) concrete levees and fences at the beginning of the 20th century (Photographer’s Archives “E. Migone”, Chiavari) and (B) embankment at present day (Photo E. Roccati) along the western riverside, Chiavari; (C) levees at the beginning of the 20th century (Photo Web) and (D) bank and Cycle path at the present day (Photo E. Roccati) along the eastern riverside, Lavagna.

- A reduction in the channel width, particularly in the final stretch, linked to the construction of fences and rudimentary levees at the end of 18th century to protect the plain from the recurrent floods, and later to the gradual construction of concrete levees, required for the building of new bridges at the mouth and the Genoa–Pisa railway line since the late 19th century (Figure 12).

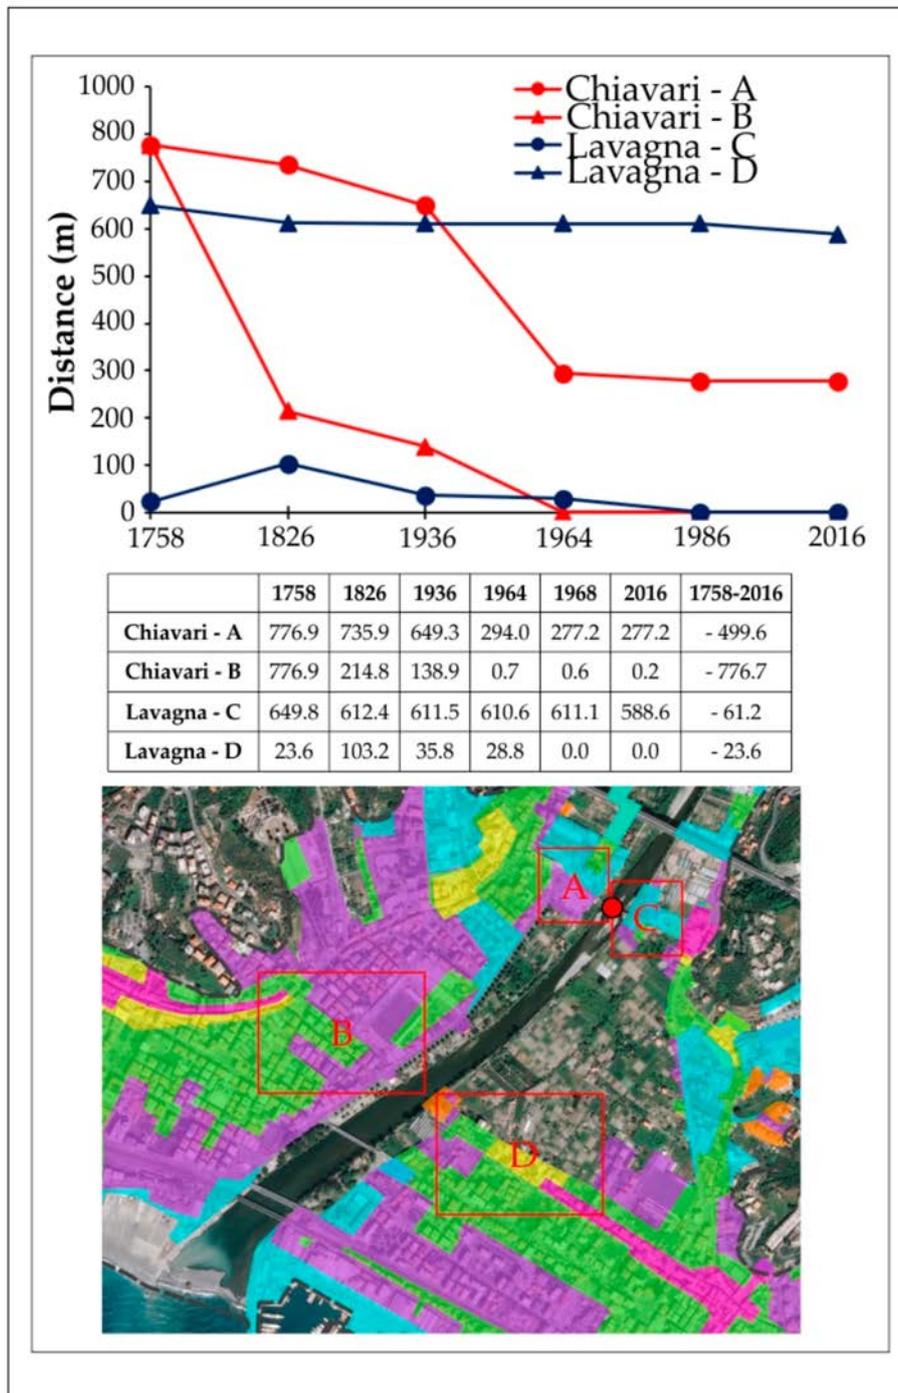
Figure 13. Variations in the distance of the river channel from the built-up area 1758–2016. A, B, C, D are the floodplain sectors (red rectangles in the map) where the distances of built-up area have been measured from the channel riversides at the “Ponte della Maddalena” bridge (red dot on map).
