**MONITORING OF MEDITERRANEAN COASTAL AREAS:
PROBLEMS AND MEASUREMENT TECHNIQUES**

Seventh International Symposium. Monitoring of Mediterranean Coastal Areas

THE COASTAL SIGHT TOWERS, A DISTINCTIVE ANTHROPIC ELEMENT OF THE ANCIENT COASTAL LANDSCAPE: THE RISK OF RESTORATION WORKS WITH EXAMPLES FROM THE TUSCAN COAST (ITALY)

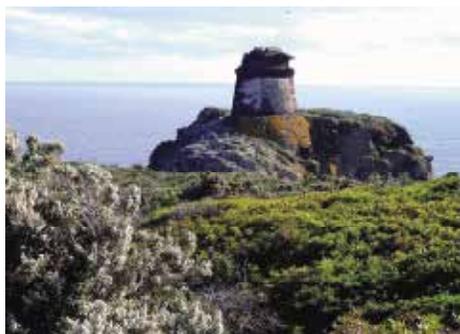
The Zenòbito tower with its striking shape still dominate the landscape (Fig. 1). It consists of a truncated cone base which continues with a cylindrical body topped by corbels that sustained a wooden balcony. At present, the tower shows important residues of the original rendering still characterized by good adhesion to the masonry which is realized according to a core structure, with the outer wall made of irregular roughly shaped volcanic rock blocks placed with quite a lot of bedding mortar. This masonry shows a good cohesion, even if the mortar joints are deeply eroded. Therefore the tower has a surface deeply marked by the time, which shows, for those who are able to decode it, a multitude of signs and information [4, 5] (Fig. 2). Nevertheless two conservation problems are present: the portion exposed southeast, where the outer wall fell down uncovering the inner core of the masonry and the deeply eroded corbels that supported the balcony.

Figure 1 – Tower of Zenòbito, Capraia.

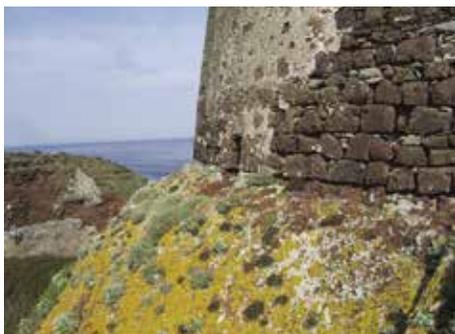
Figure 2 – Tower of Zenòbito: rock basement and residues of plaster.

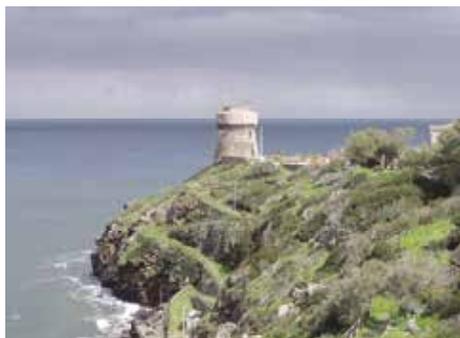
The tower of Porto (Fig. 3), sited on the promontory east of the harbour, shows an aspect similar to that of Zenòbito, but with a smaller diameter. It has been recently restored.

Figure 3 – Tower of Porto, Capraia.

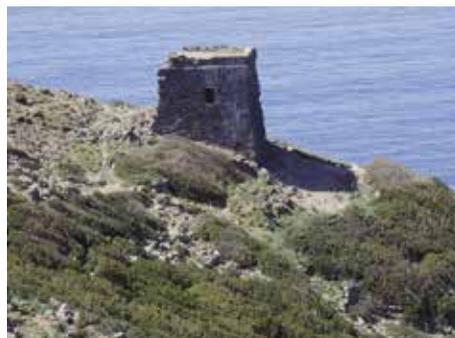
The tower of Barbici, (Fig. 4) has a square base and was realized according to a core structure, made of roughly shaped volcanic rock blocks placed with a lot of mortar. The eastern side shows little residues of the original rendering but in the complex the masonry is deeply eroded and in the southern side the outer wall has completely collapsed.

Figure 4 – Tower of Barbici, Capraia.

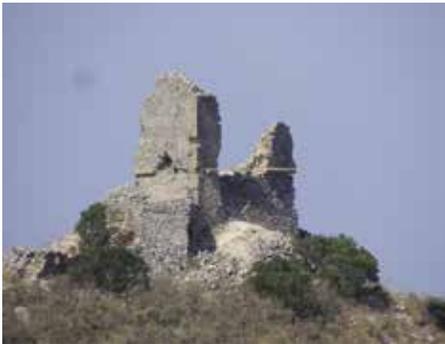
The tower of Capodomo is a square tower which had probably three floors. At present only the basement and the first floor are still standing (Fig.5). Externally the tower is characterized by a buttress that runs along its entire perimeter ending with a cornice marking the position of the flooring of the first floor. The building technique can be classified as a coursed square rubble masonry [8], characterized by the use of roughly dressed stones, well cut corner stones and thick layers of bedding mortars. This buttress differs from the upper masonry for some specific architectonic elements like the corner stones, the cornice, the windows and doors frames. In such cases the stones are well dressed with a finished surface. Inside, the tower is constituted by a ground floor where a tank is located topped by a barrel vault, sustained by another adjoining room, also vaulted. Above, a well preserved two-layers mortar flooring (two distinct construction phases) is visible.

Figure 5 – Tower of Capodomo, Argentario.

As for the state of conservation, we have already mentioned that the two towers look like ruins. The stones of the masonry are in good condition because they are made of compact, highly durable rocks. The most delicate part of the masonry is constituted by the bedding mortars. In fact, the mortar joints, while presenting good cohesion, are eroded and this has caused the enucleation and separation of stone blocks, especially on the unprotected wall crests.

Concerning the building materials of Capodomo tower in Argentario, the dressed stones of the masonry are made of calcitic grey marble with traces of dolomite belonging to the Unit of Cala Piatti (Middle-Upper Trias), outcropping nearby the tower, while the cornice and the corner stones are made of a brownish Cavernous Limestone (Upper Trias) belonging to the same Unit. The bedding mortars of the wall nucleus are quite fat with a calcic magnesian binder and a heterogeneous aggregate constituted mainly by carbonatic rock fragments (micro and macro crystalline), quartz, lumps and presence of earth residues. The plasters show always a calcic magnesian binder (as indicated also by the presence of hydromagnesite and brucite, evidenced through XRD analysis). The aggregate is heterogeneous with the presence of carbonatic rock fragments (dolomite from XRD data), quartz, lumps, sometimes shale and silicatic rock fragments, crushed ceramics, earth residues. The mix is fatter with respect to the bedding mortars.

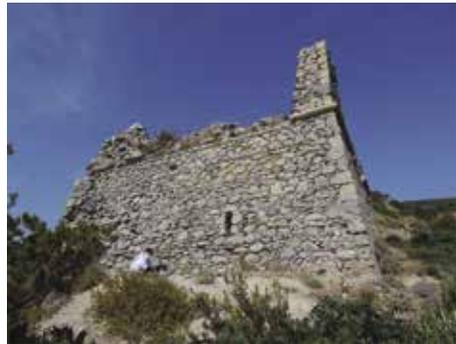
The Calamoresca tower is a square tower, composed of a single constructive phase and characterized by a masonry realized with stones, split and put in place on uneven rows (uncoursed square rubble masonry) and well cut corner stones (Fig. 6). The tower is characterized by a buttress that runs along its entire perimeter ending with a cornice marking the height of the flooring of the first floor.

Figure 6 – Tower of Calamoresca, Argentario.

As for the building materials of Calamoresca tower, the dressed stones are made of dark grey dolomite with calcitic white veins belonging to the Unit of Cala Piatti (Upper Trias) outcropping nearby the tower, the cornice is made of Cavernous Limestone similar to that of Capodomo and the corner stones are made with a dark grey porous limestone. Both mortars (bedding mortar and plaster) are quite fat with a calcic magnesian binder (XRD data) and a heterogeneous aggregate constituted by carbonatic rocks (the same of the dressed stones), earth residues, quartz, and rare metamorphic rock fragments.

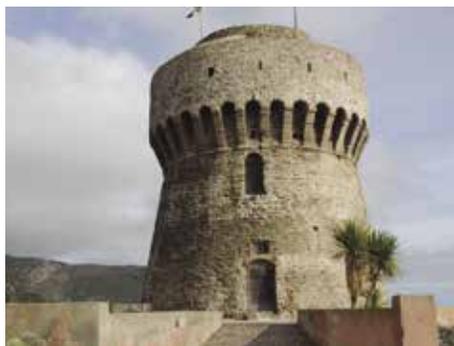
Taking into account these considerations, the restoration of the tower of Porto, although it might seem a good intervention to the normal not aware persons, unfortunately has not been able to keep on the surface the track of time, completely removing the remains of the original plaster and sealing with a new mortar the joints of the original bedding mortar (Fig. 7, 8).

Figure 7 – The tower of Porto, restored.

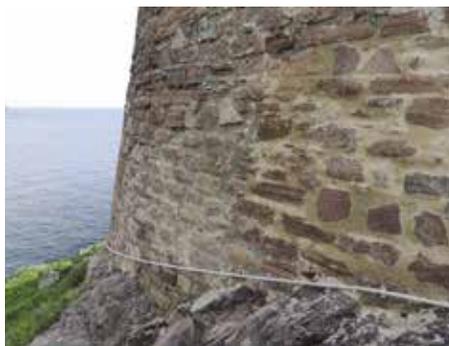
Figure 8 – Tower of Porto: restored surface.

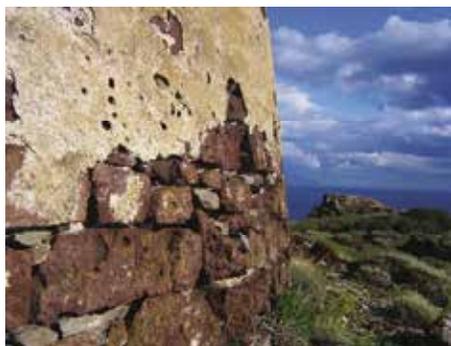
In particular, for the Zenòbito tower, the extensive remains of the ancient plaster coating must be preserved, still characterized by a good adhesion to the masonry (Fig. 9), but avoiding covering the rest of the surface where the plaster is missing with a new plaster that would completely distort the appearance of the ruin. Rather, in the portion exposed to the south-east, where the external masonry has fallen exposing the nucleus, an intervention is necessary to stop the progress of decay with the consequent fall of stone elements (Fig.10). Nevertheless, it should be a "not invasive" localized intervention, with: punctual fixing of the blocks which are detaching, additions of bedding mortar in small amount where necessary; punctual application of eco- friendly consolidating products and protectives. The same punctual light intervention should be carried out in the upper part of

Figure 9 – Tower of Zenòbito: the eroded masonry with the ancient plaster

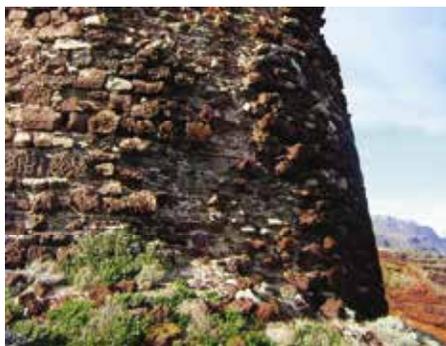
Figure 10 – Tower of Zenòbito: exposed nucleus of the masonry

the cylindrical body where the corbels that supported the wooden balcony (no longer present) are deeply eroded and in some cases missing [20, 21].
